25/30 YEAR MILESTONE INSPECTION

**Ormond Heritage Condominium Management
Association
1 John Anderson Drive
Ormond Beach, FL 32176**

Reference: **25/30 Year Phase I Milestone Structural Inspections for Condominium and Cooperative Buildings**

UES Project No: 0415.2200355.0000

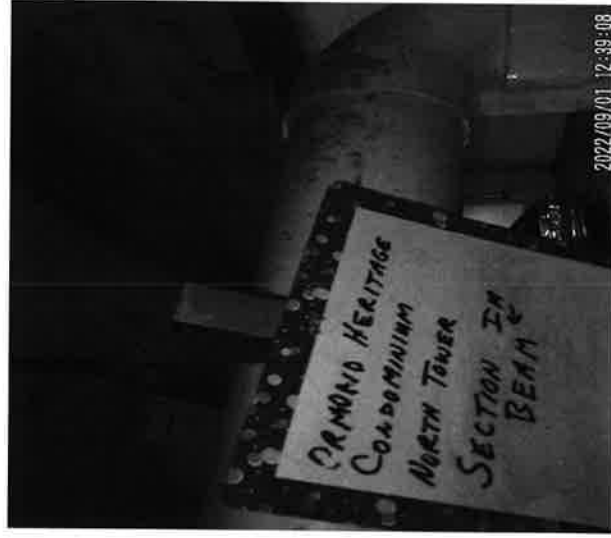
Photo 64

- Foundation – Cracks/Separation
- North Tower, Section IA Beam

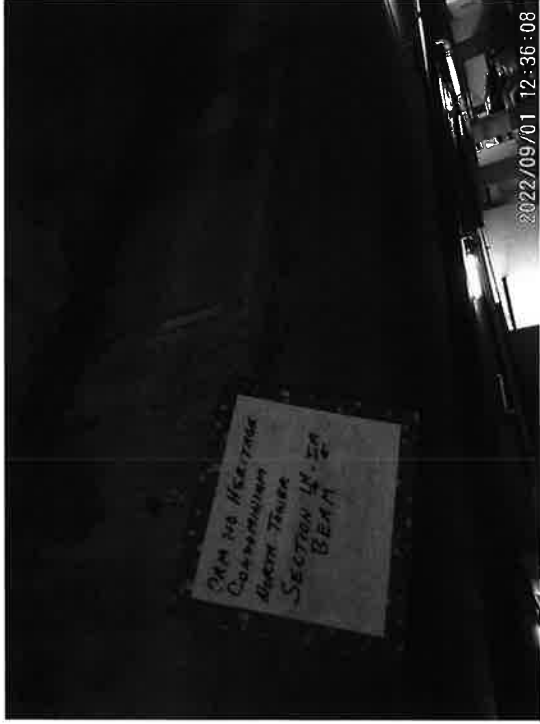
Photo 66

- Foundation – Cracks/Separation
- North Tower, Section LH - IA Beam

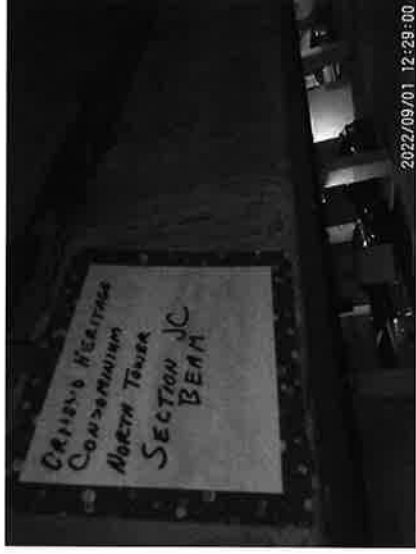
Photo 68

- Foundation – Cracks/Separation
- North Tower, Section JC Beam

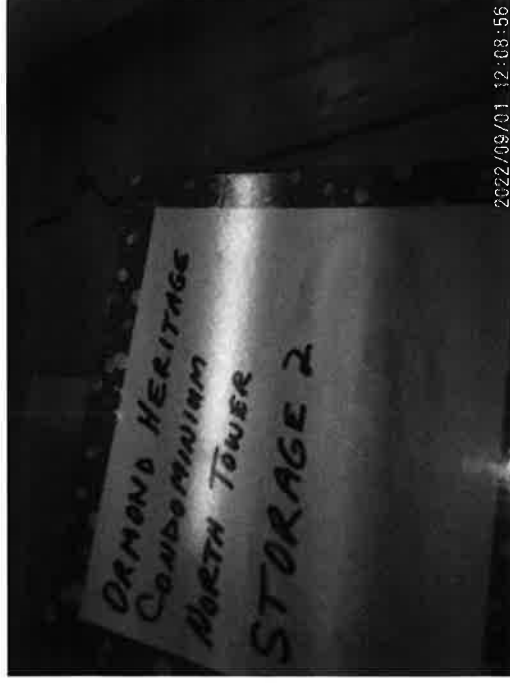
Photo 74

- Foundation – Cracks/Separation
- North Tower, Storage 2

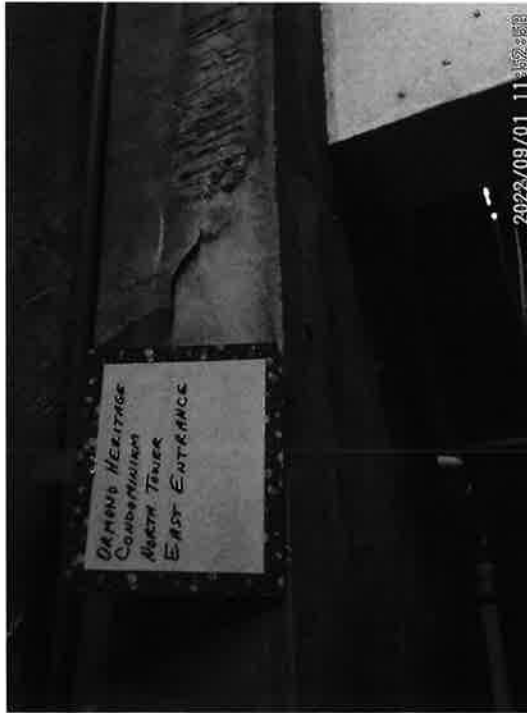
Photo 76

- Foundation – Cracks/Separation
- North Tower, East Entrance

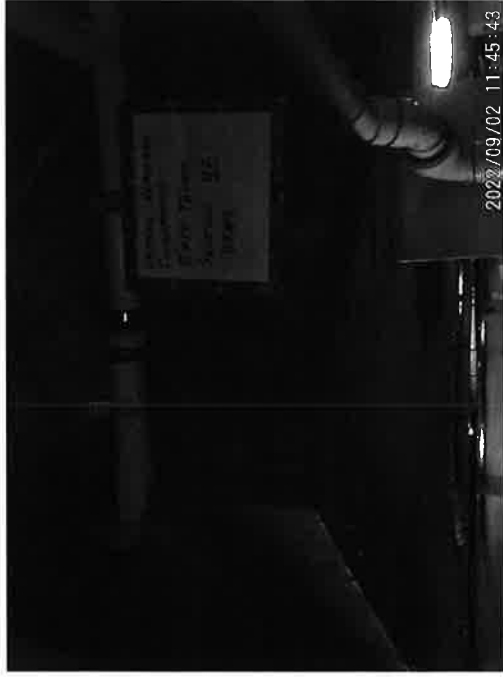
Photo 12

- Portion showing Distress/Surface Conditions in the Parking Garage
- East Tower, Section UZ Beam

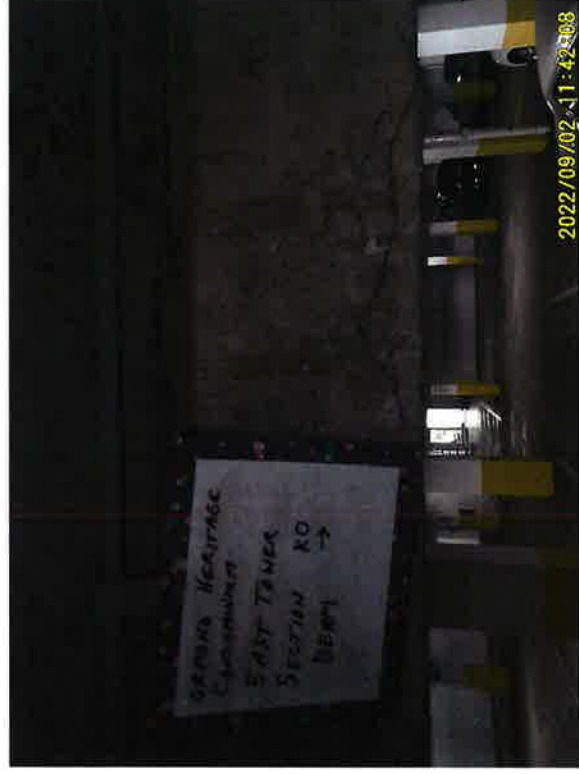
Photo 14

- Portion showing Distress/Surface Conditions in the Parking Garage
- East Tower, Section KO Beam

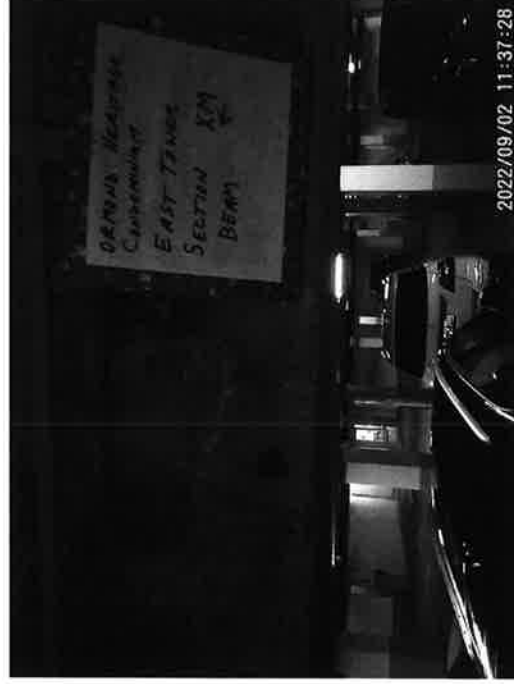
Photo 15

- Portion showing Distress/Surface Conditions in the Parking Garage
- East Tower, Section XM Beam

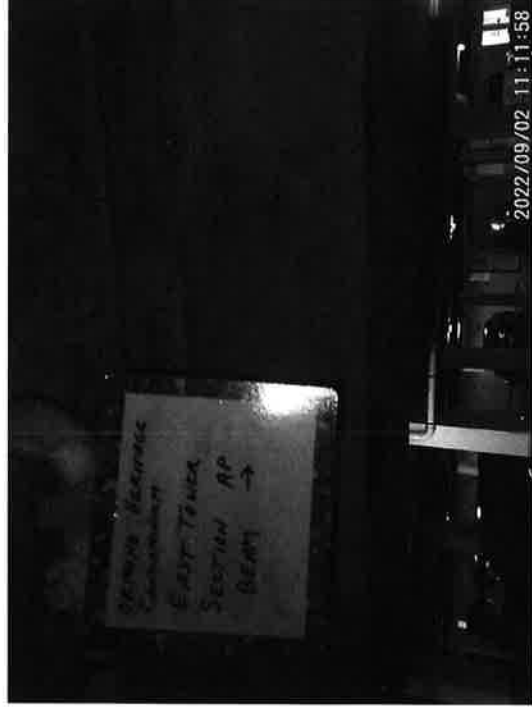
Photo 16

- Portion showing Distress/Surface Conditions in the Parking Garage
- East Tower, Section AP Beam

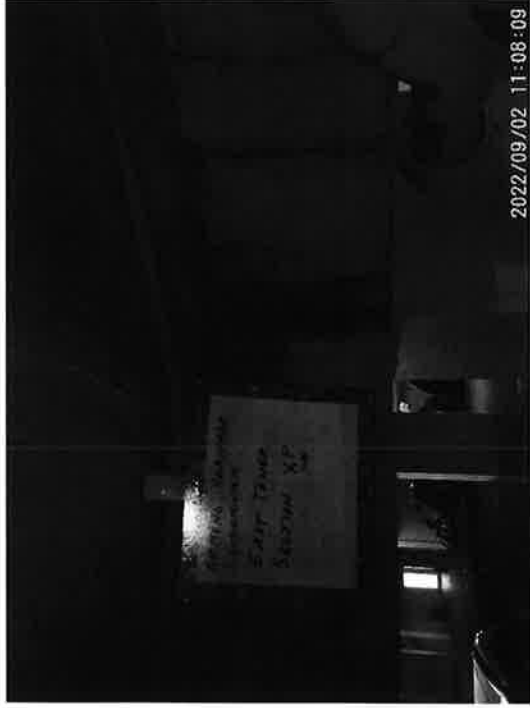
Photo 17

- Portion showing Distress/Surface Conditions in the Parking Garage
- East Tower, Section XP Beam

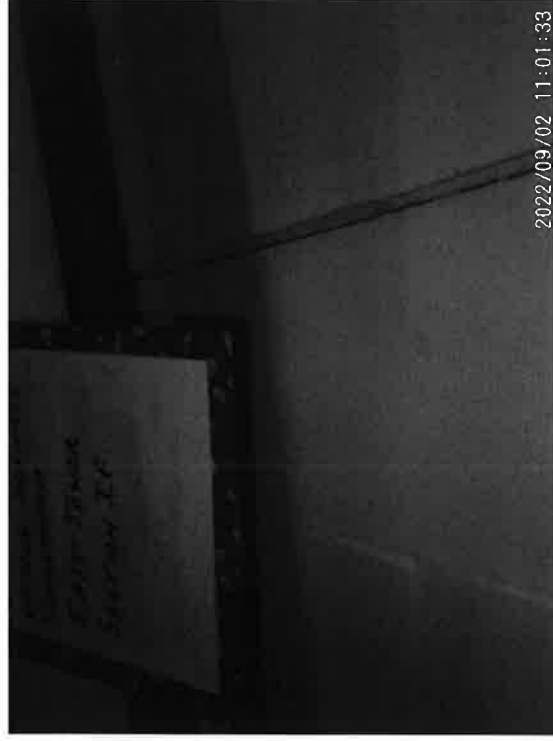
Photo 18

- Portion showing Distress/Surface Conditions in the Parking Garage
- East Tower, Section IF Beam

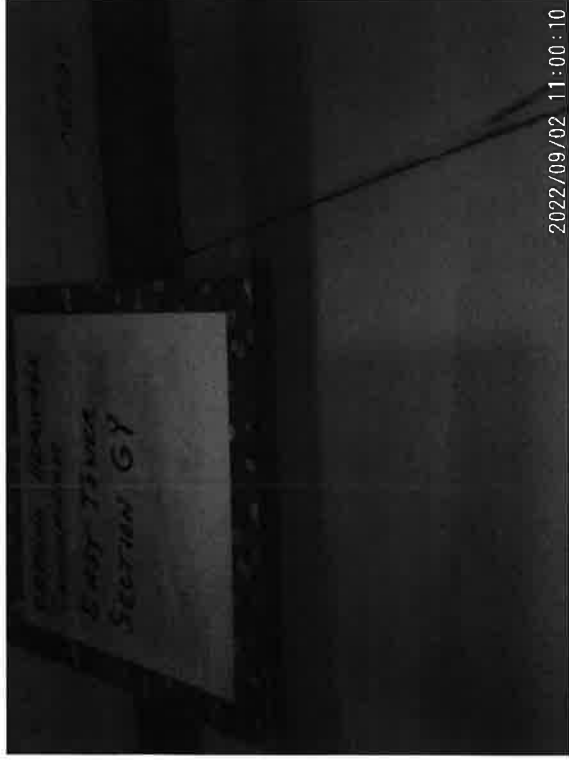
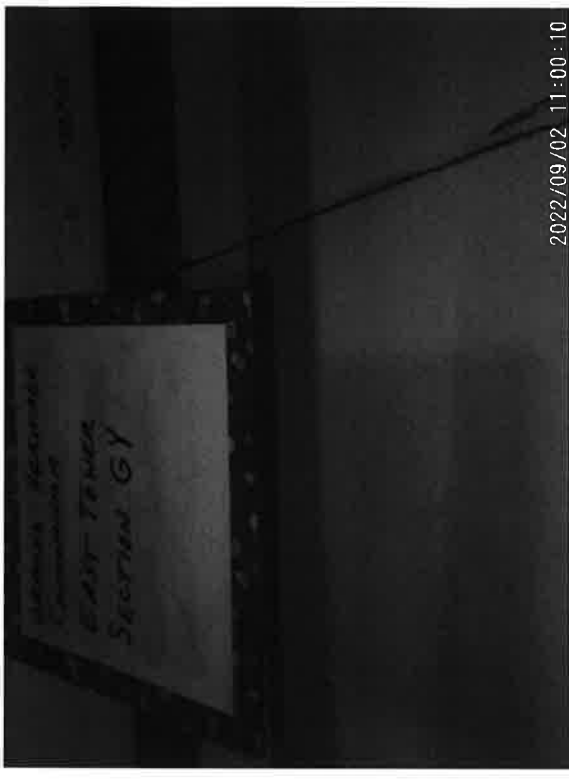
Photo 19

- Portion showing Distress/Surface Conditions in the Parking Garage
- East Tower, Section GY Beam

- Portion showing Medium Cracks in the Parking Garage
- East Tower, Section GY

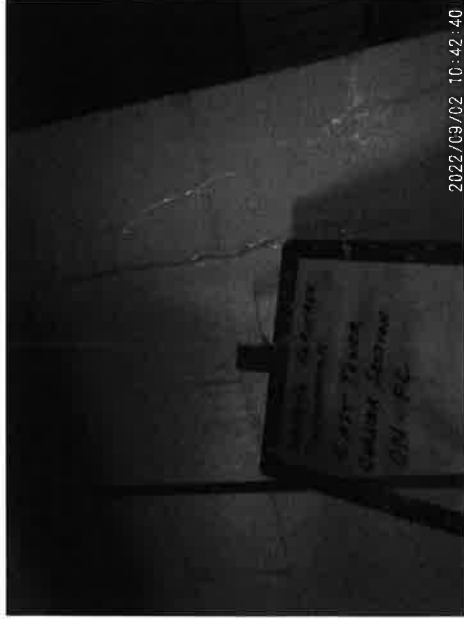
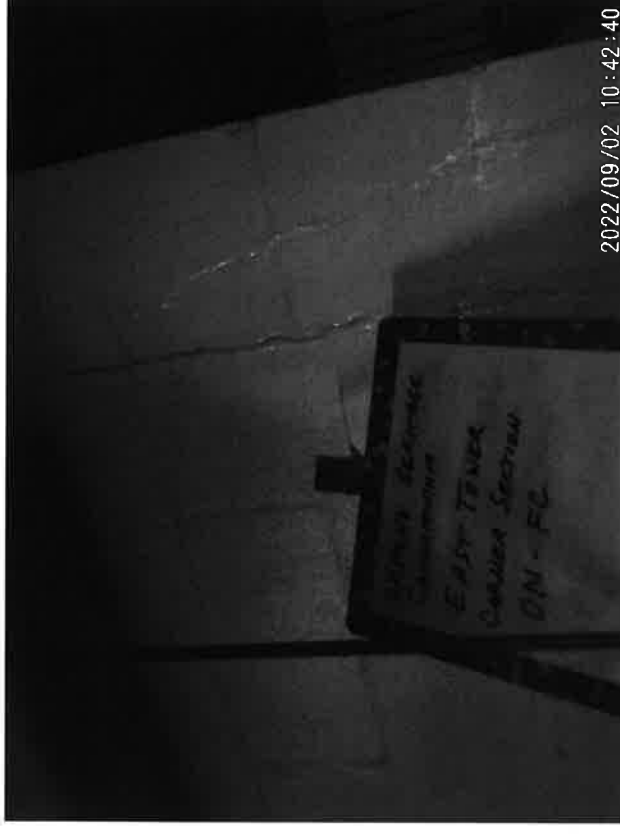
Photo 20

- Portion showing Distress/Surface Conditions in the Parking Garage
- East Tower, Corner Section ON - FC Beam

- Portion showing Medium Cracks in the Parking Garage
- East Tower, Corner Section ON-FC

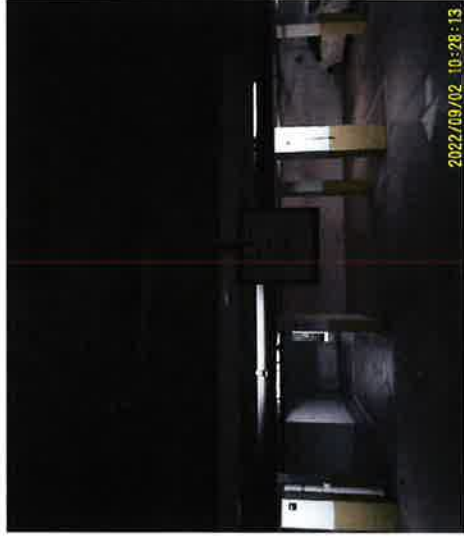
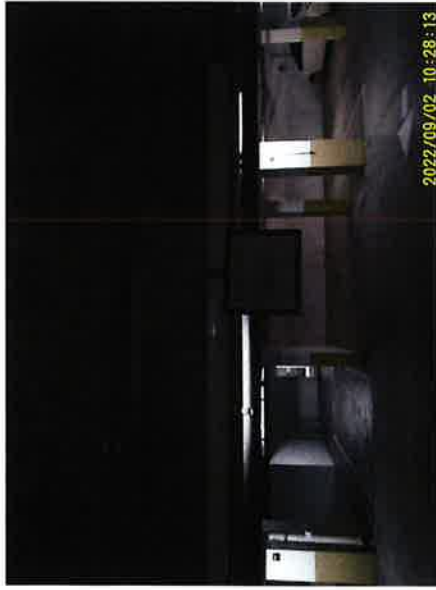
Photo 25

- Portion showing Distress/Surface Conditions in the Parking Garage
- South Tower, Section GL Beam

- Portion showing Medium Cracks in the Parking Garage
- South Tower, Section GL Beam

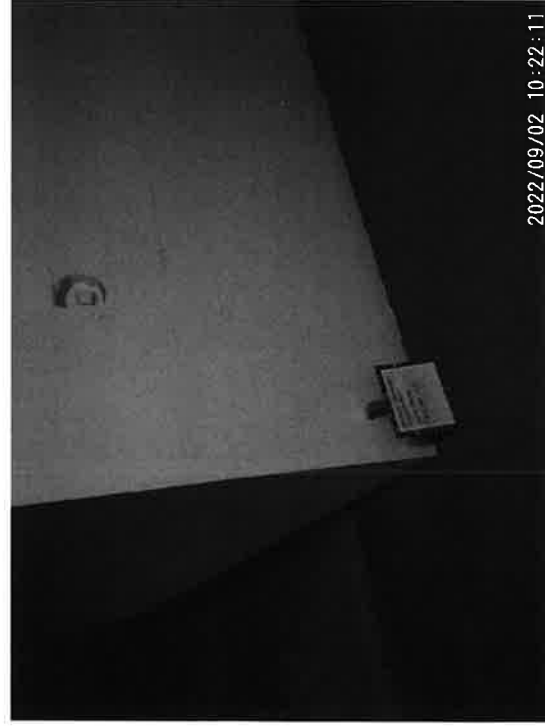
Photo 28

- Portion showing Distress/Surface Conditions in the Parking Garage
- South Tower, Section MO Beam

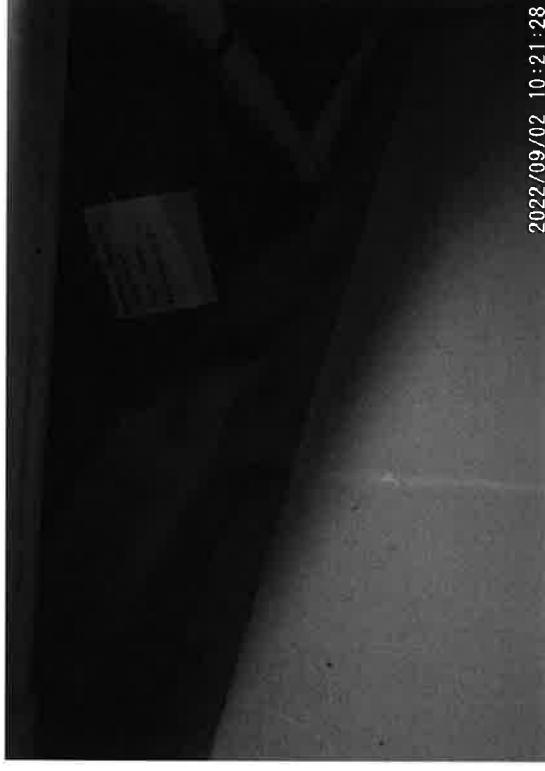
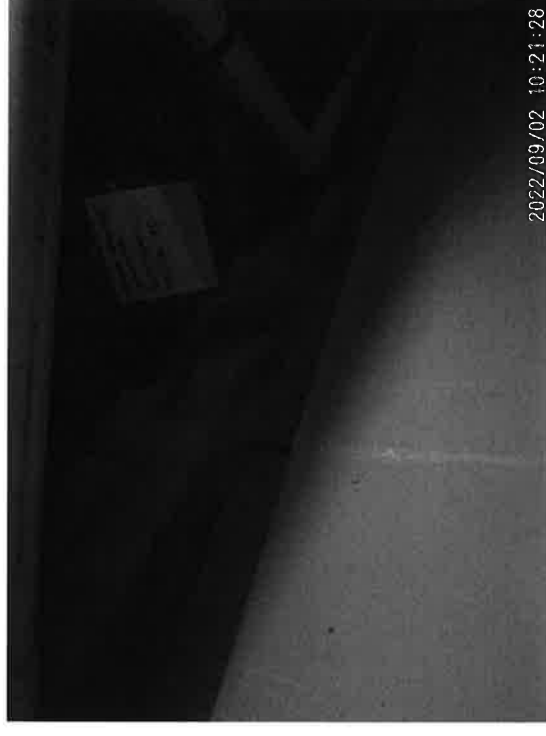
Photo 29

- Portion showing Medium Cracks in the Parking Garage
- South Tower, Section MO

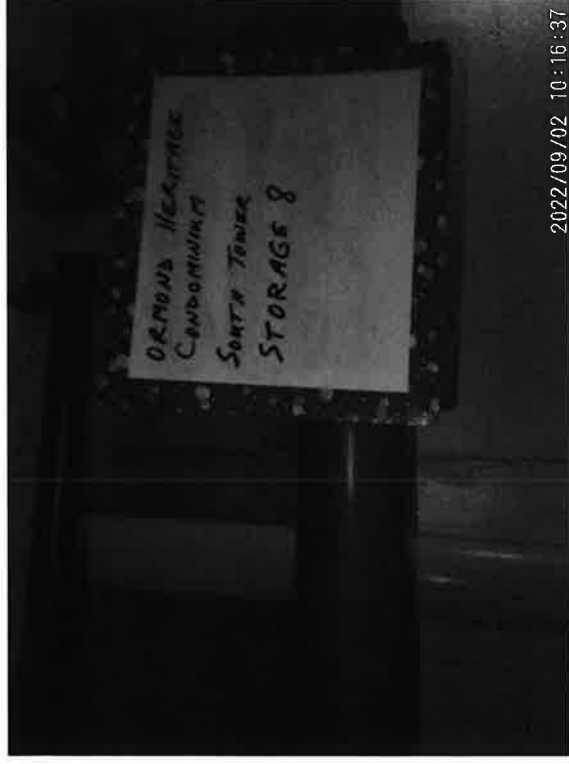
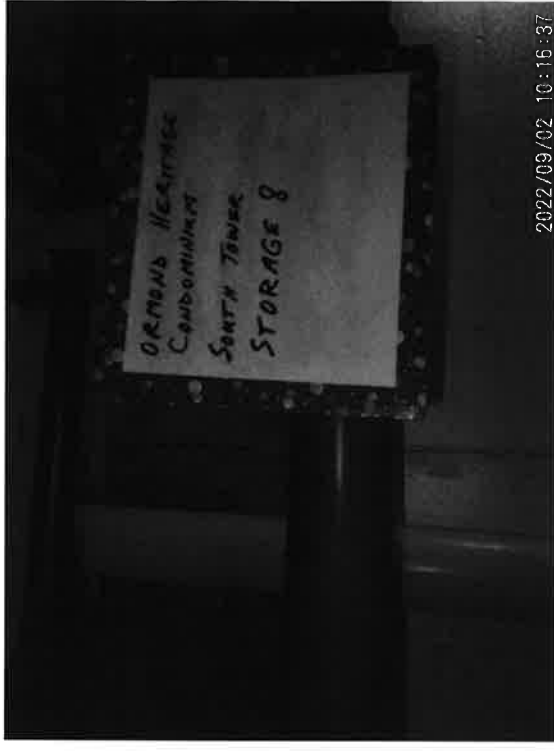
Photo 30

- Portion showing Distress/Surface Conditions in the Parking Garage
- South Tower, Storage 8

- Portion showing Medium Cracks in the Parking Garage
- South Tower, Storage 8

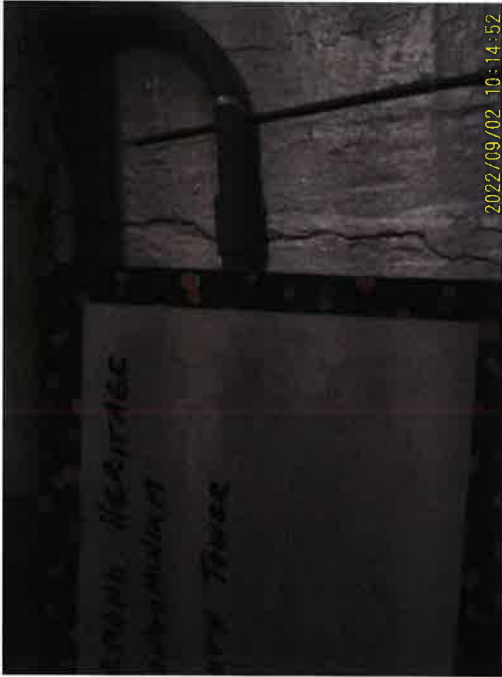
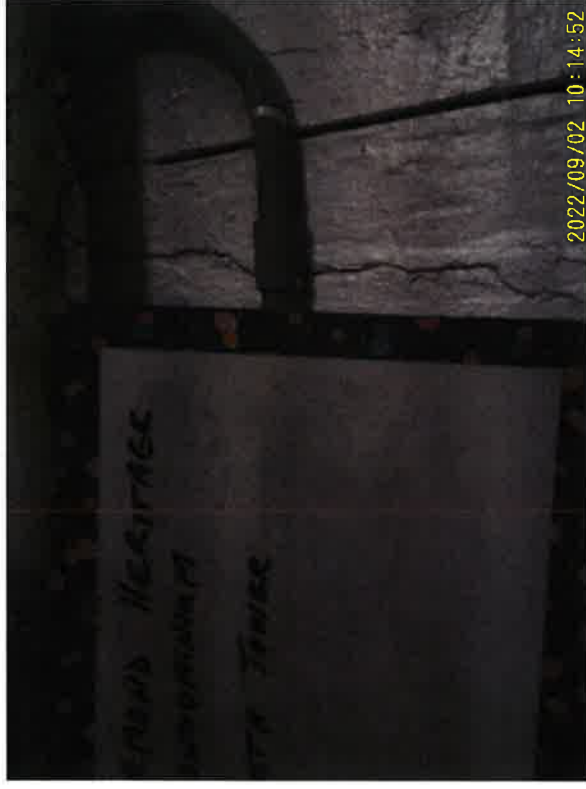
Photo 31

- Portion showing Distress/Surface Conditions in the Parking Garage
- South Tower

- Portion showing Medium Cracks in the Parking Garage
- South Tower

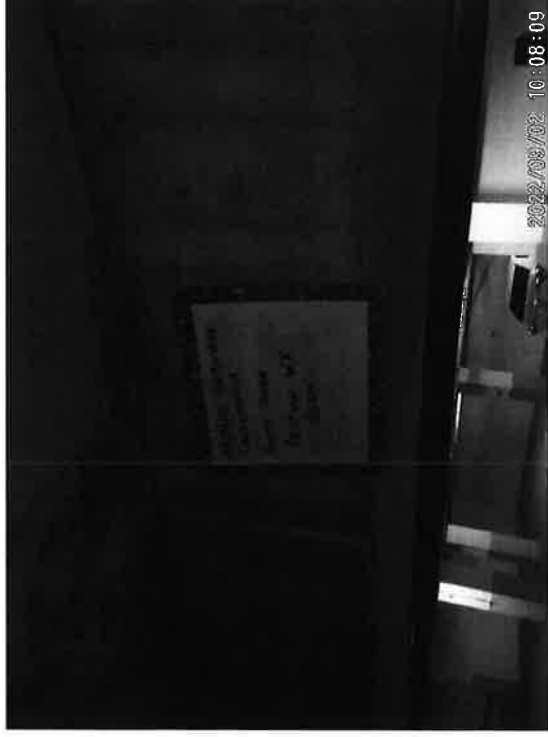
Photo 33

- Portion showing Distress/Surface Conditions in the Parking Garage
- South Tower, Section WX Beam

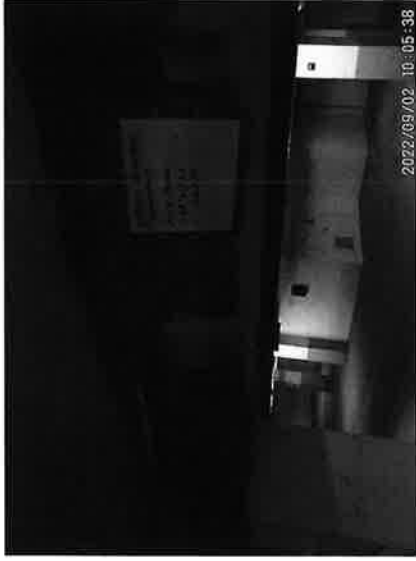
Photo 34

- Portion showing Distress/Surface Conditions in the Parking Garage
- South Tower, Carwash Beam

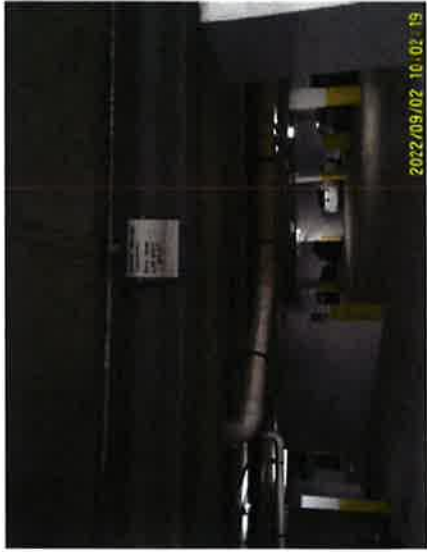
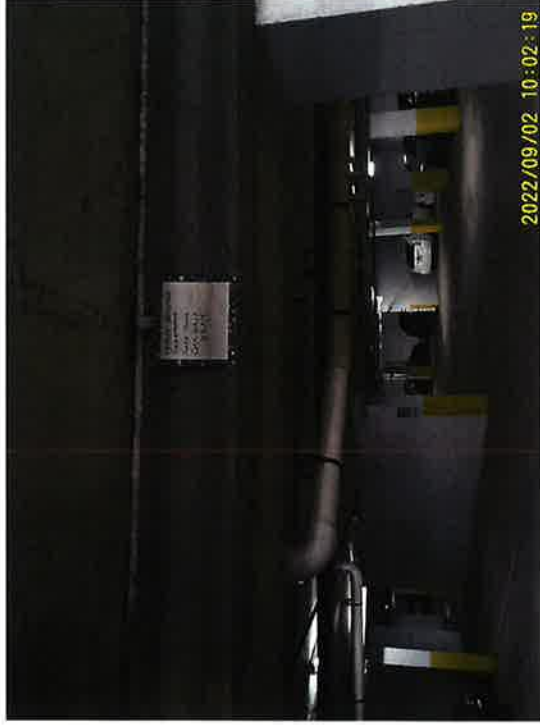
Photo 37

- Portion showing Distress/Surface Conditions in the Parking Garage
- South Tower, Carwash Beam continued...

- Portion showing Medium Cracks in the Parking Garage
- South Tower, Car Wash Beam
