# PHASE 2 MILESTONE INSPECTION

## **Ormond Heritage Condominiums**

## 1 John Anderson Drive

UES Project No: 0811.2400043.0000

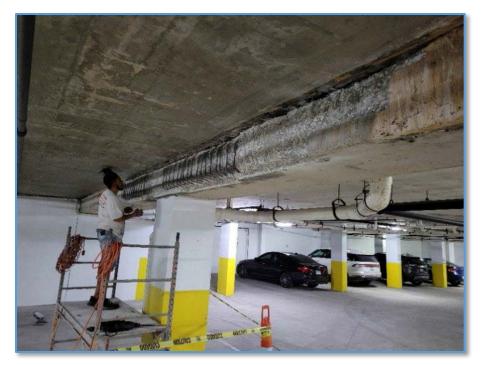
Photograph No. 1: North Garage Beam Repair (Picture obtained from North Garage Beam Progress Report #1 by The Ormond Heritage Condominium Management Association, Inc.).

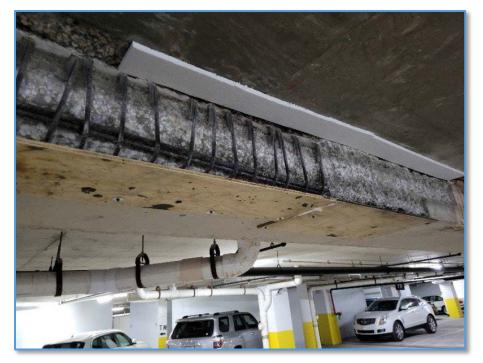
Photograph No. 2: North Garage Beam Repair (Picture obtained from North Garage Beam Progress Report #1 by The Ormond Heritage Condominium Management Association, Inc.).

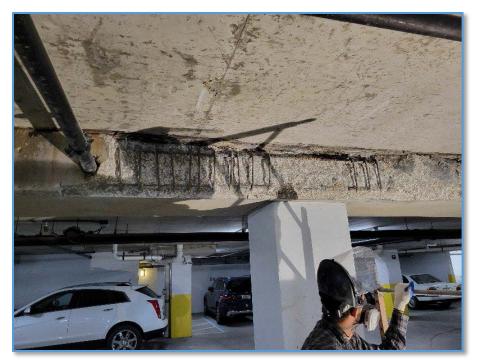
Photograph No. 3: North Garage Beam Repair (Picture obtained from North Garage Beam Progress Report #1 by The Ormond Heritage Condominium Management Association, Inc.).

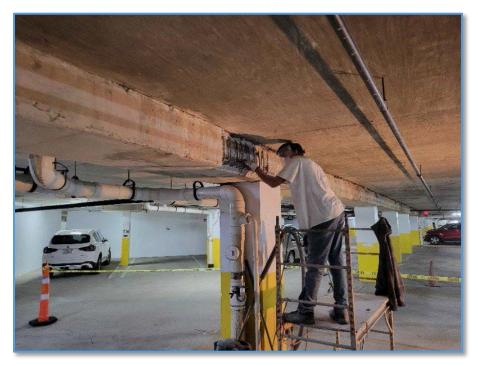
Photograph No. 4: North Garage Beam Repair (Picture obtained from North Garage Beam Progress Report #1 by The Ormond Heritage Condominium Management Association, Inc.).

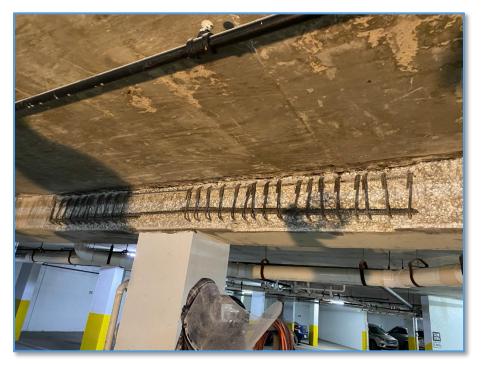
Photograph No. 5: North Garage Beam Repair (Picture obtained from Field Observation Report by United Engineering Consultants, Inc.).

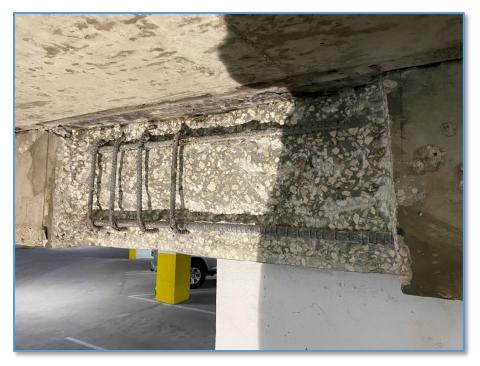
Photograph No. 6: North Garage Beam Repair (Picture obtained from Field Observation Report by United Engineering Consultants, Inc.).

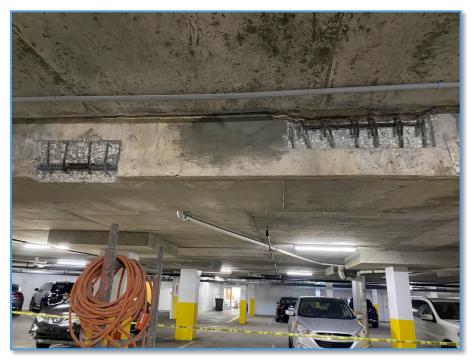
Photograph No. 7: North Garage Beam Repair (Picture obtained from Field Observation Report by United Engineering Consultants, Inc.).

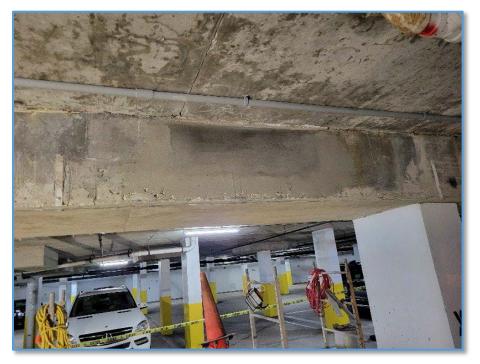
Photograph No. 8: North Garage Beam Repair (Picture obtained from North Garage Beam Progress Report #2 by The Ormond Heritage Condominium Management Association, Inc.).

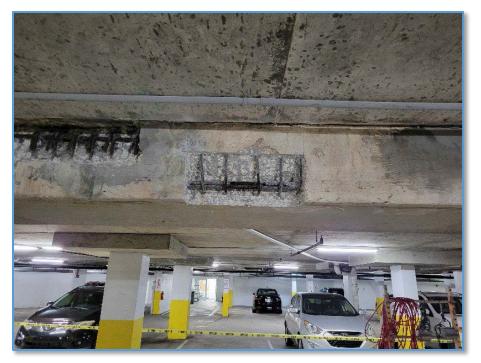
Photograph No. 9: North Garage Beam Repair (Picture obtained from North Garage Beam Progress Report #1 by The Ormond Heritage Condominium Management Association, Inc.).

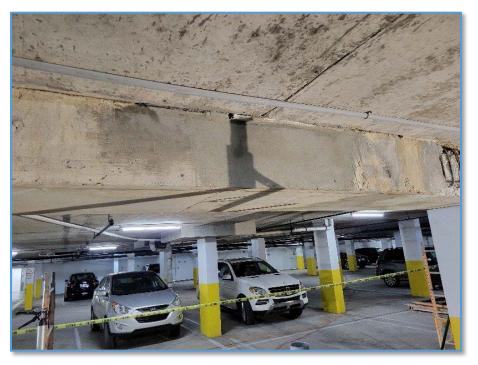
Photograph No. 10: North Garage Beam Repair (Picture obtained from North Garage Beam Progress Report #1 by The Ormond Heritage Condominium Management Association, Inc.).

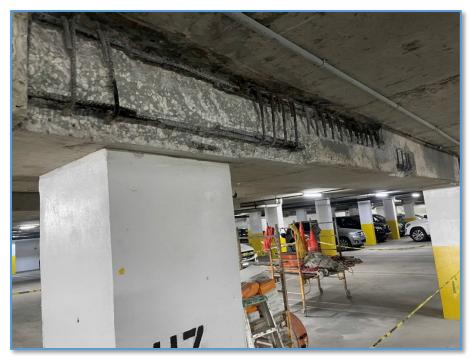
Photograph No. 11: East Garage Beam Repair (Picture obtained from Field Observation Report by United Engineering Consultants, Inc.).

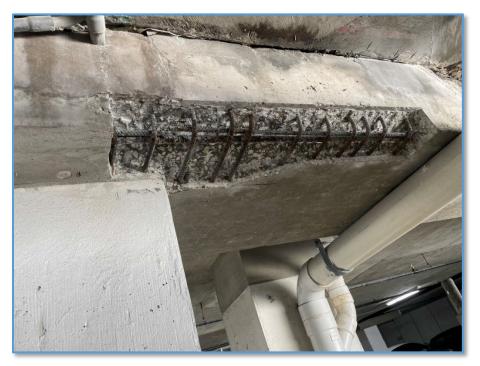
Photograph No. 12: East Garage Beam Repair (Picture obtained from Field Observation Report by United Engineering Consultants, Inc.).

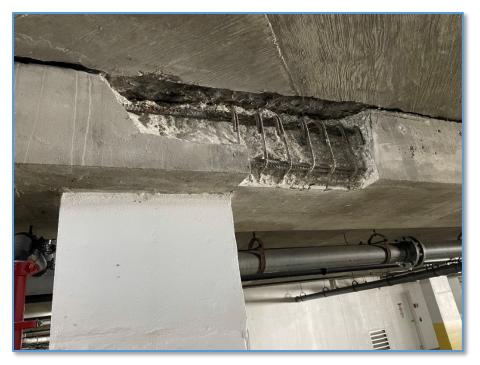
Photograph No. 13: East Garage Beam Repair (Picture obtained from Field Observation Report by United Engineering Consultants, Inc.).

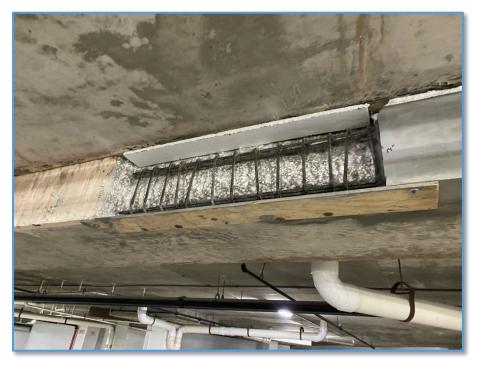
Photograph No. 14: South Garage Beam Repair (Picture obtained from Field Observation Report by United Engineering Consultants, Inc.).

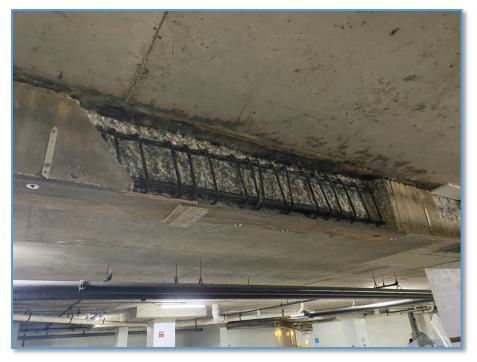
Photograph No. 15: South Garage Beam Repair (Picture obtained from Field Observation Report by United Engineering Consultants, Inc.).

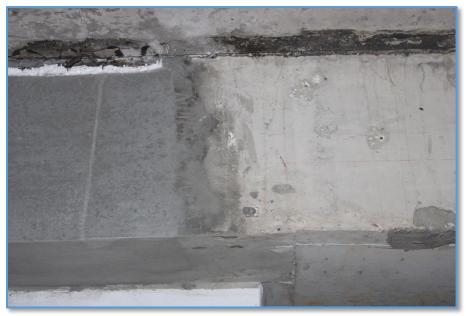
Photograph No. 16: Garage Beam Repair (Picture obtained UES inspection).
