CITY OF ORMOND BEACH

Building Division • 22 S. Beach Street • Room104 • Ormond Beach • Florida • 32174 • (386) 676 -3233

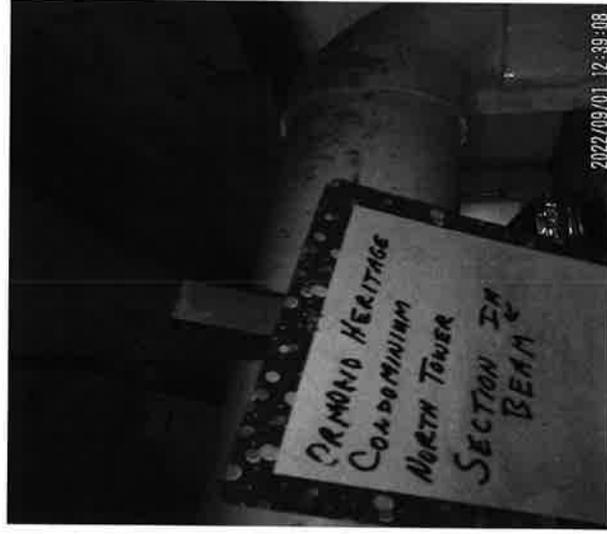
- Foundation – Cracks/Separation
- North Tower, Section IA Beam

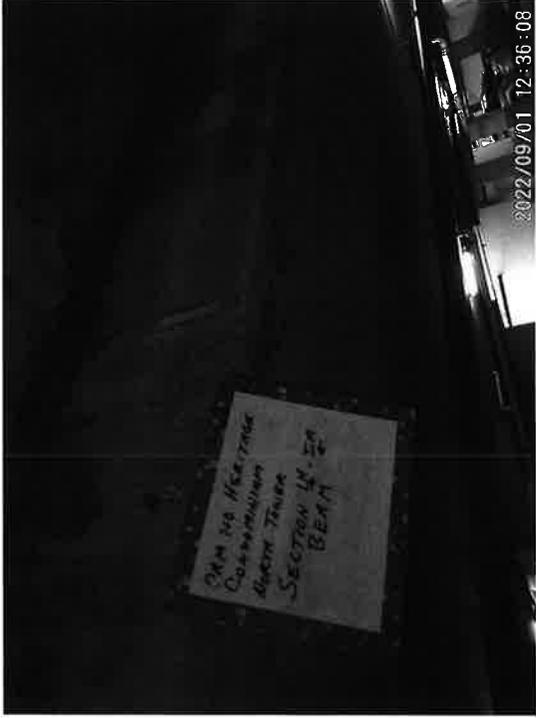
- Foundation – Cracks/Separation
- North Tower, Section LH - IA Beam

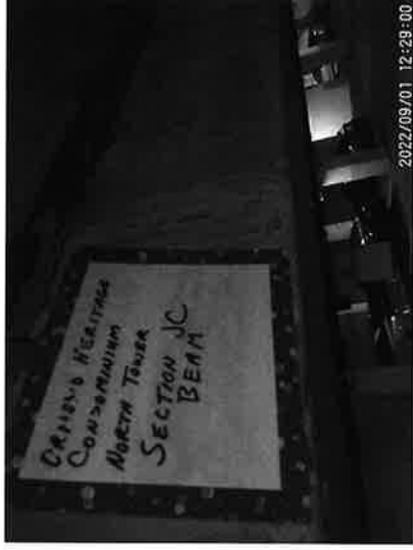
- Foundation – Cracks/Separation
- North Tower, Section JC Beam

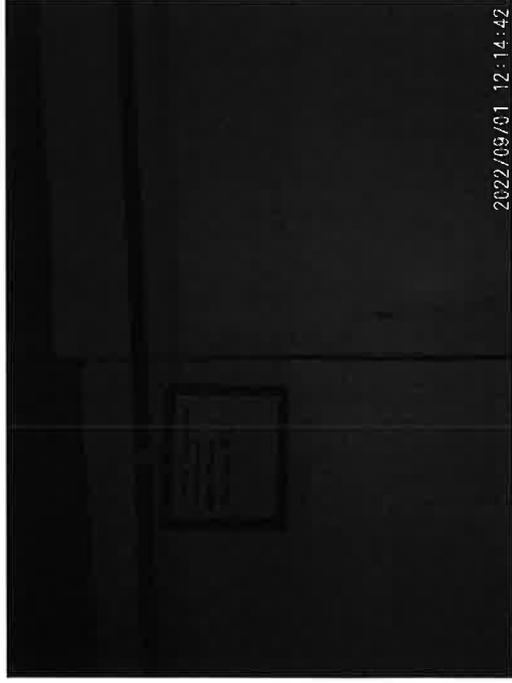
- Foundation – Cracks/Separation
- North Tower, Section RL

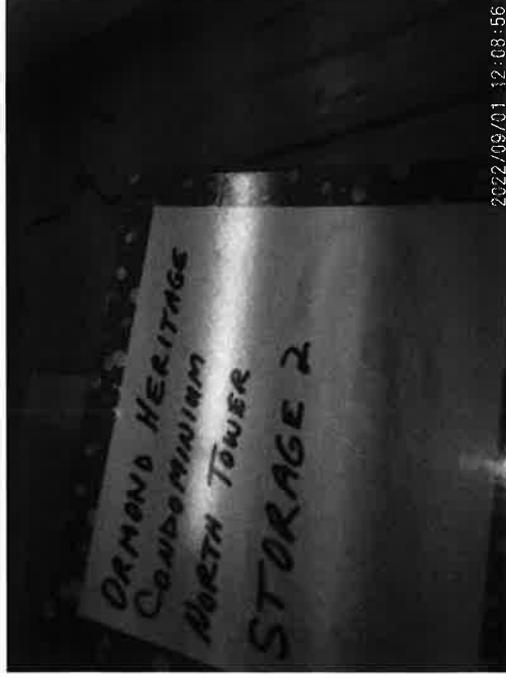
- Foundation – Cracks/Separation
- North Tower, Storage 2

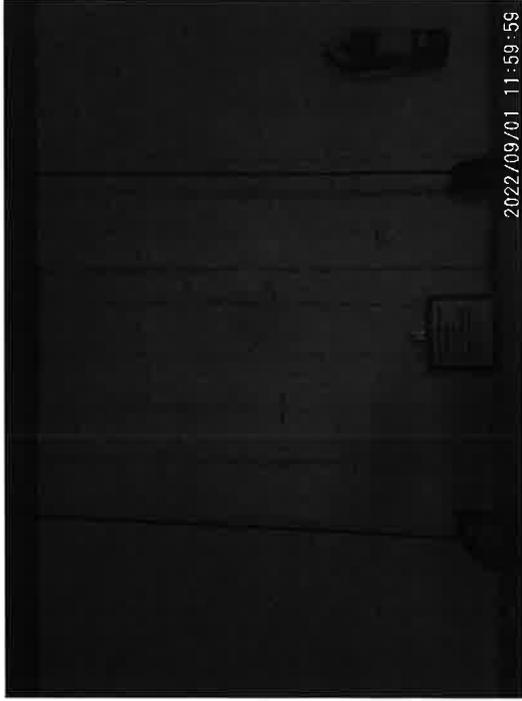
- Foundation – Cracks/Separation
- North Tower, East Entrance, Water Intrusion, Section SG

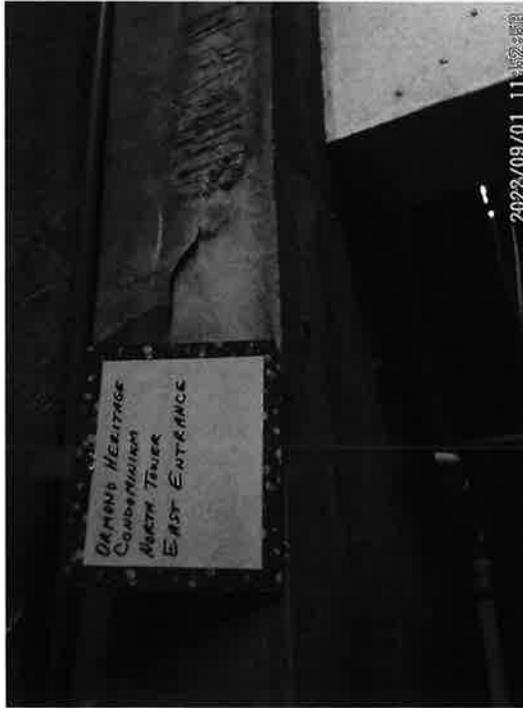
- Foundation – Cracks/Separation
- North Tower, East Entrance

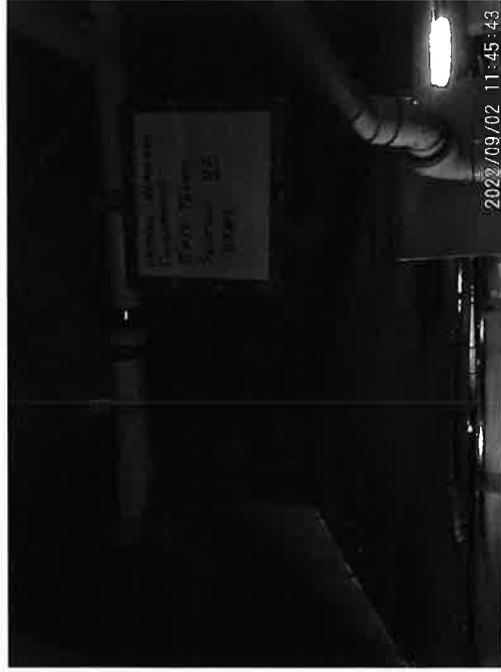
- Portion showing Distress/Surface Conditions in the Parking Garage
- East Tower, Section UZ Beam

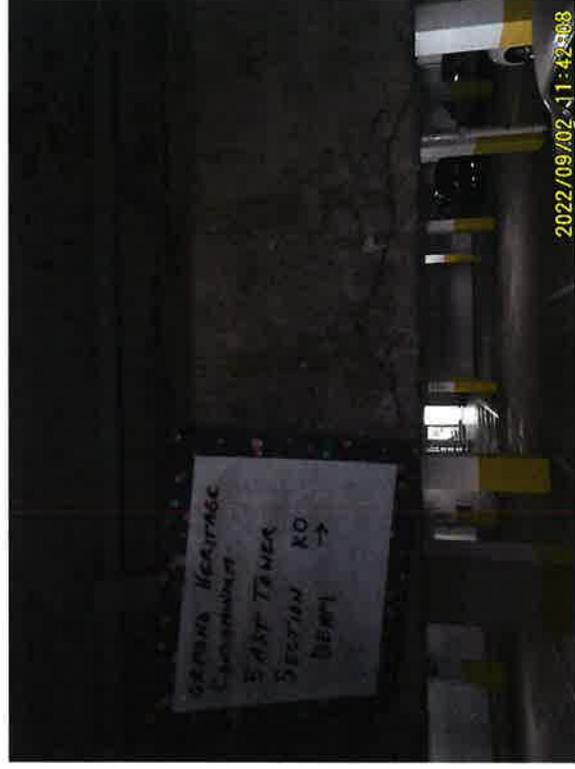
- Portion showing Distress/Surface Conditions in the Parking Garage
- East Tower, Section KO Beam

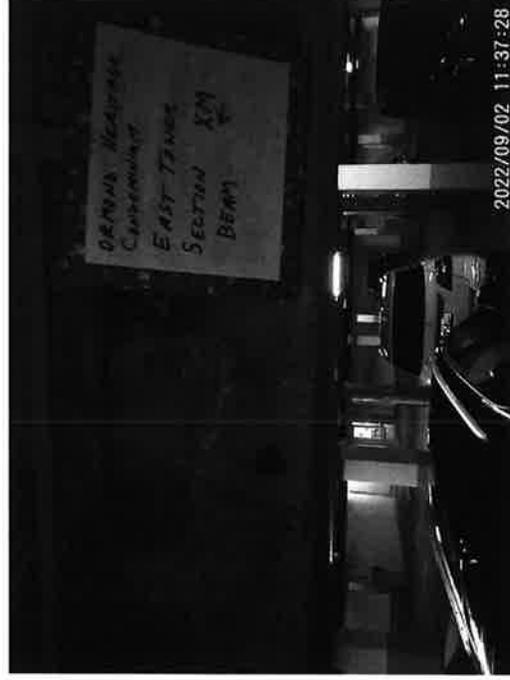
- Portion showing Distress/Surface Conditions in the Parking Garage
- East Tower, Section XM Beam

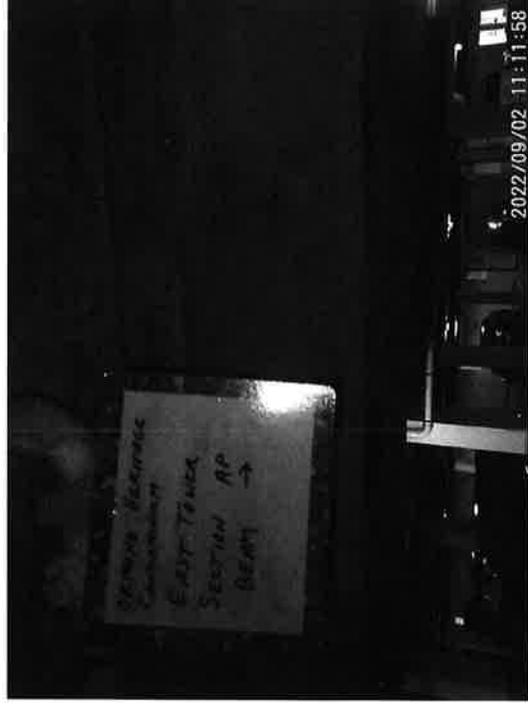
- Portion showing Distress/Surface Conditions in the Parking Garage
- East Tower, Section AP Beam

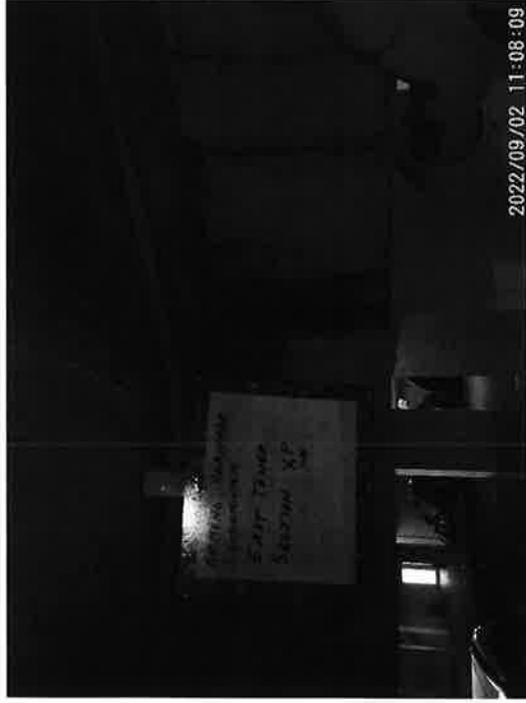
- Portion showing Distress/Surface Conditions in the Parking Garage
- East Tower, Section XP Beam

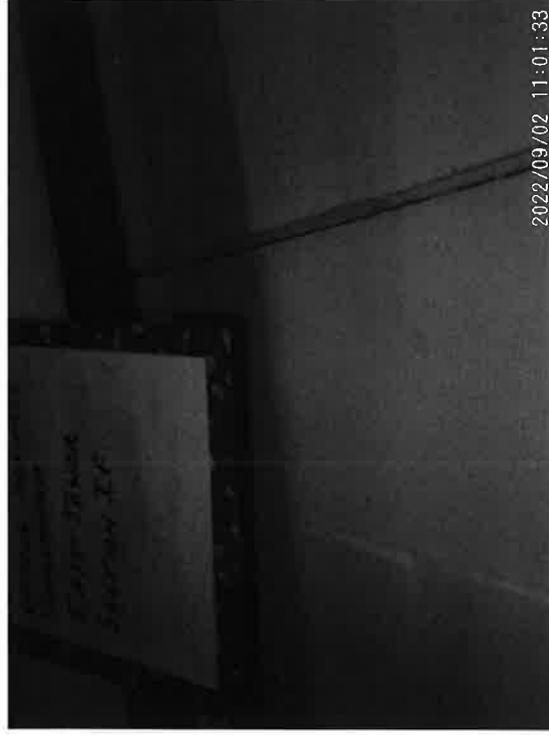
- Portion showing Distress/Surface Conditions in the Parking Garage
- East Tower, Section IF Beam

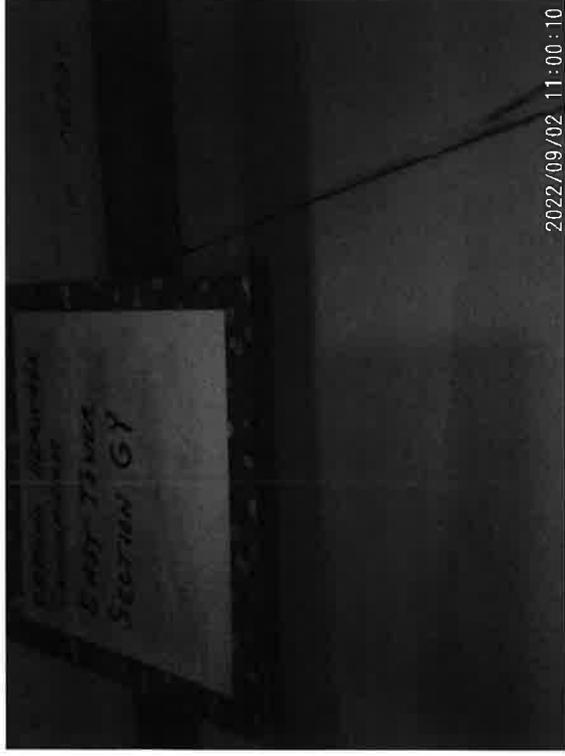
- Portion showing Distress/Surface Conditions in the Parking Garage
- East Tower, Section GY Beam

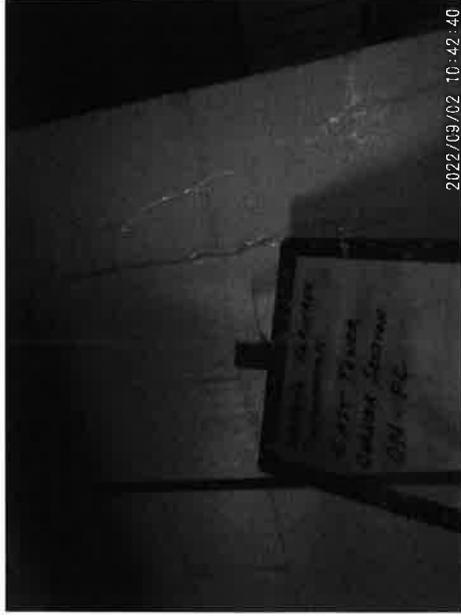
- Portion showing Distress/Surface Conditions in the Parking Garage
- East Tower, Corner Section ON - FC Beam

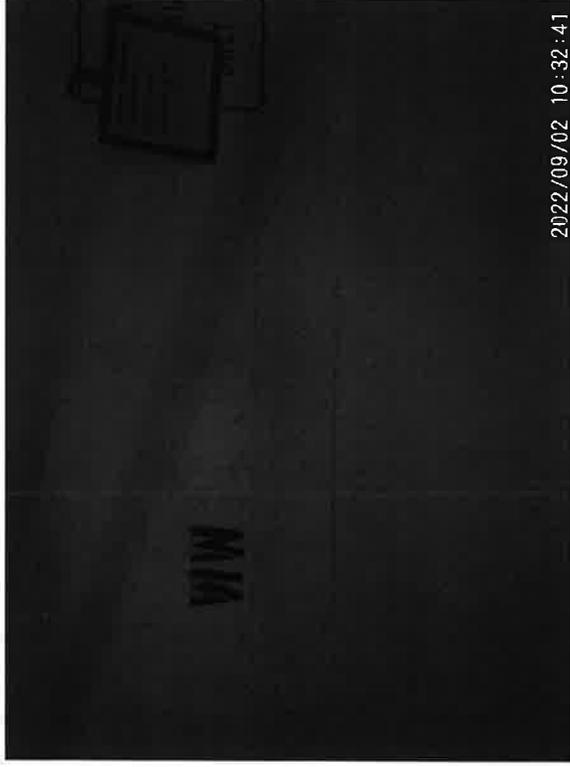
- Portion showing Distress/Surface Conditions in the Parking Garage
- South Tower, Section WW Beam

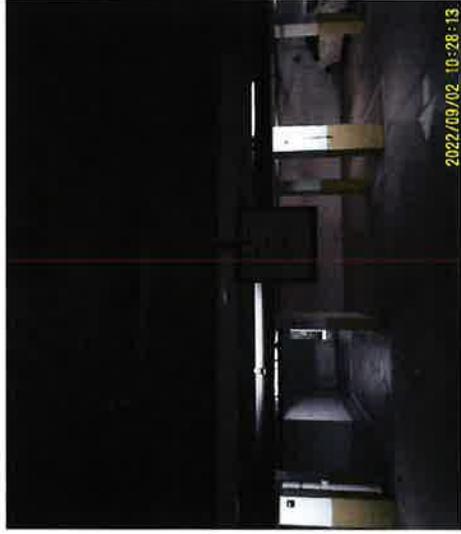
- Portion showing Distress/Surface Conditions in the Parking Garage
- South Tower, Section GL Beam

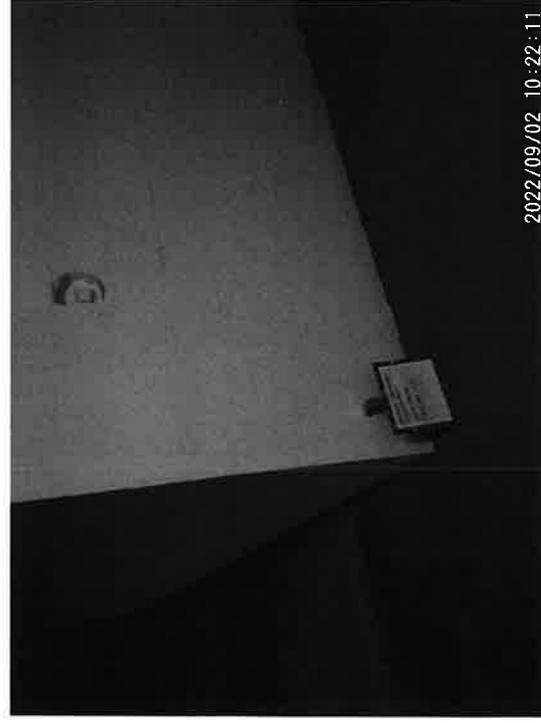
- Portion showing Distress/Surface Conditions in the Parking Garage
- South Tower, Section MO Beam

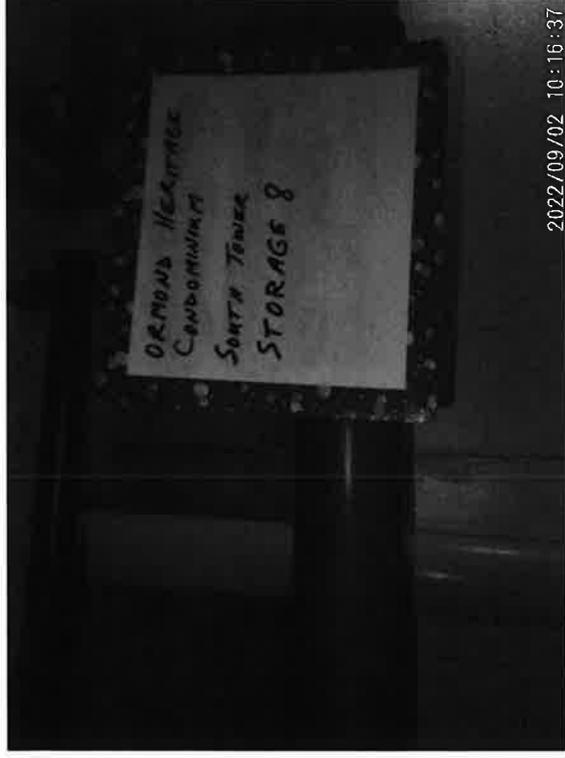
- Portion showing Distress/Surface Conditions in the Parking Garage
- South Tower, Storage 8

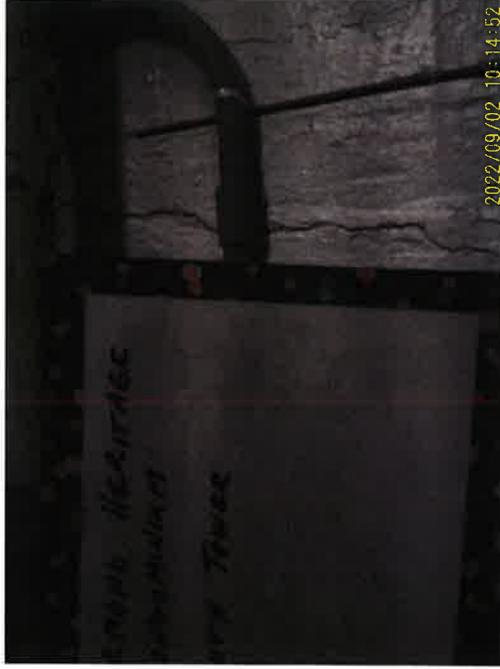
- Portion showing Distress/Surface Conditions in the Parking Garage
- South Tower

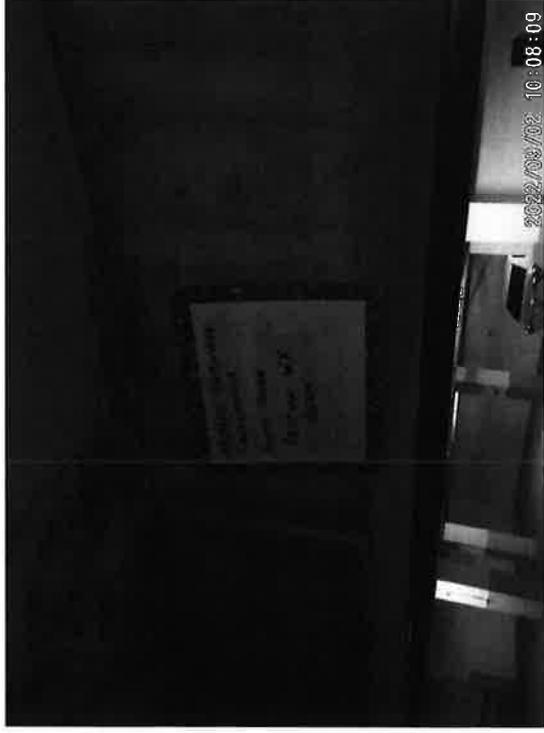
- Portion showing Distress/Surface Conditions in the Parking Garage
- South Tower, Section WX Beam

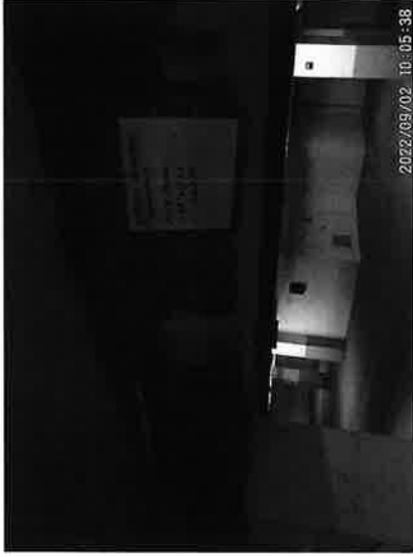
- Portion showing Distress/Surface Conditions in the Parking Garage
- South Tower, Carwash Beam

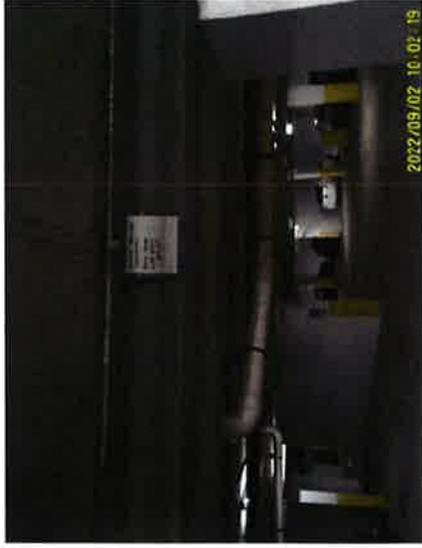
- Portion showing Distress/Surface Conditions in the Parking Garage
- South Tower, Carwash Beam continued...

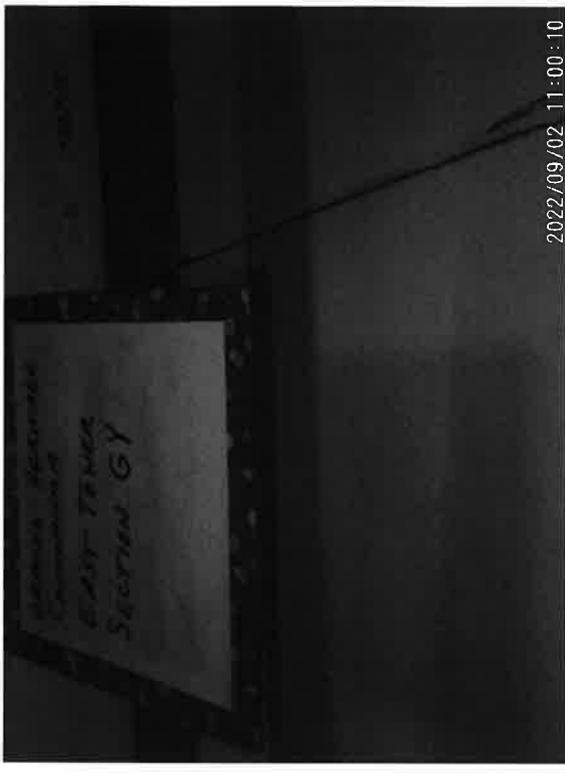
- Portion showing Medium Cracks in the Parking Garage
- East Tower, Section GY

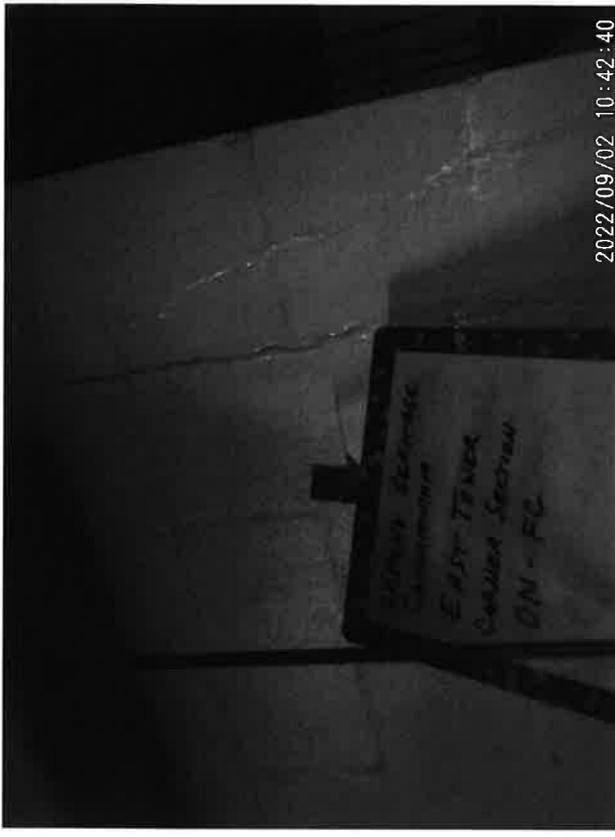
- Portion showing Medium Cracks in the Parking Garage
- East Tower, Corner Section ON-FC

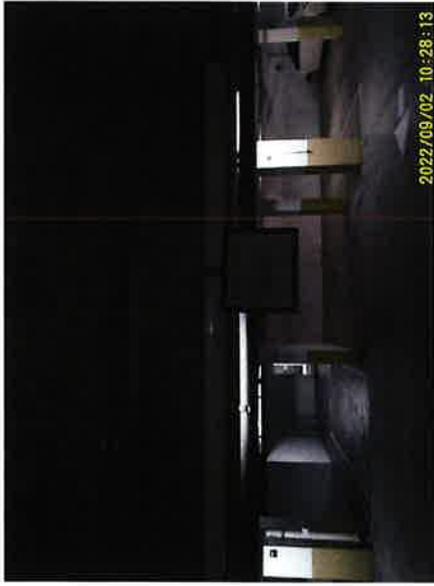
- Portion showing Medium Cracks in the Parking Garage
- South Tower, Section GL Beam

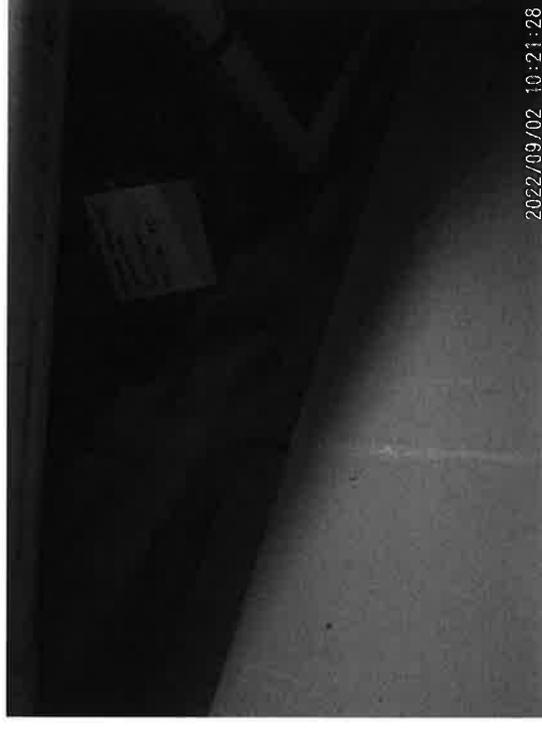
- Portion showing Medium Cracks in the Parking Garage
- South Tower, Section MO

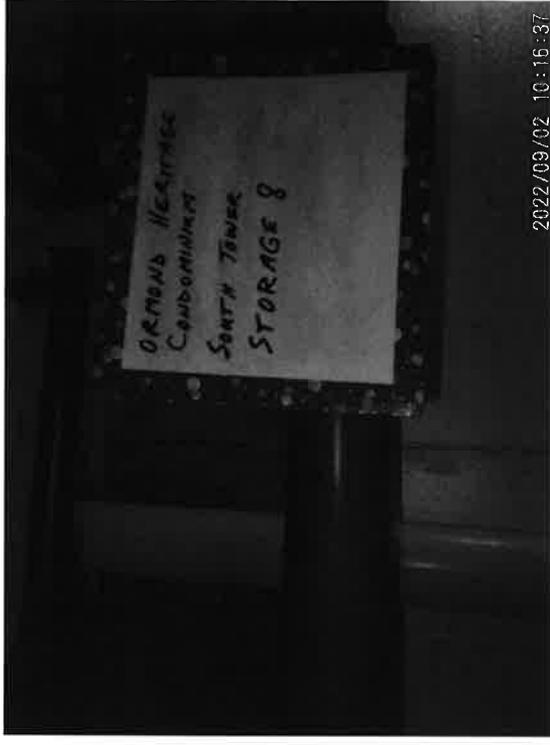
- Portion showing Medium Cracks in the Parking Garage
- South Tower, Storage 8

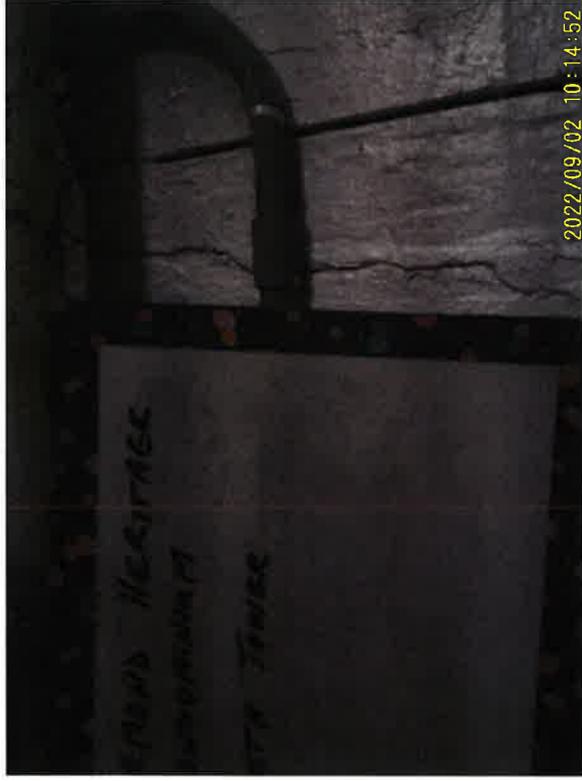
- Portion showing Medium Cracks in the Parking Garage
- South Tower

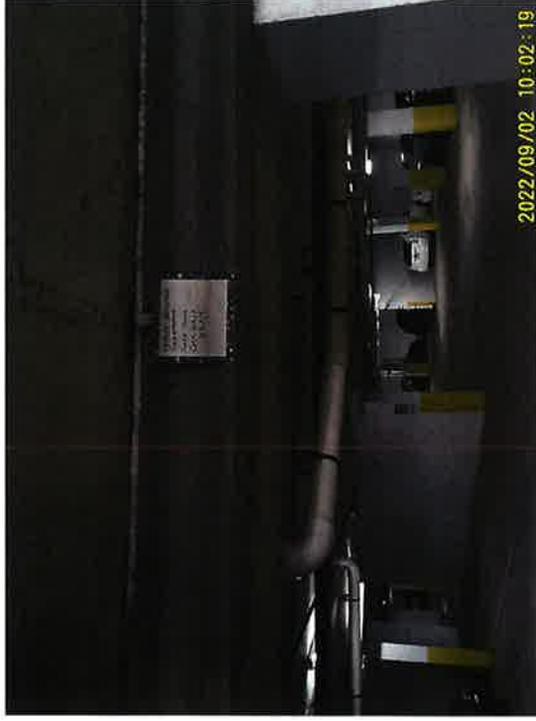
- Portion showing Medium Cracks in the Parking Garage
- South Tower, Car Wash Beam
