25/30 YEAR MILESTONE INSPECTION

**Ormond Heritage Condominium Management
Association
1 John Anderson Drive
Ormond Beach, FL 32176**

Reference: **25/30 Year Phase I Milestone Structural Inspections for Condominium and Cooperative Buildings**

UES Project No: 0415.2200355.0000

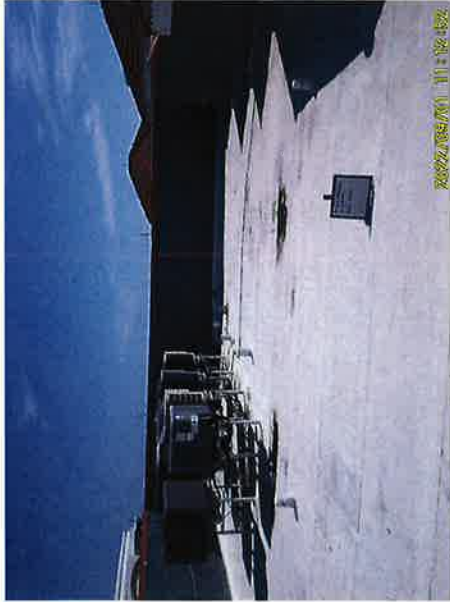
Photo 78

Flat roof system - 2 inches of lightweight concrete with single ply membrane. Evidence of ponding as visualized in photos provided. Photo 78, 79, 80, 81, 82, 87, 88, 89, 90, 91, 92, 93, 94, 101, and 102

- Describe Roof Type
- North Tower – Evidence of Ponding

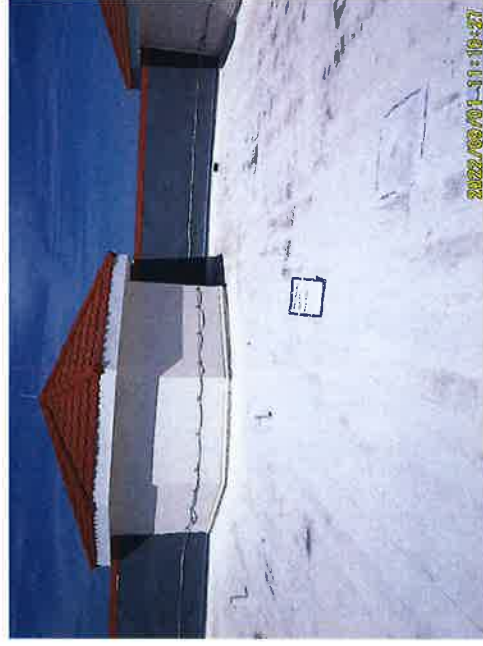
Photo 81

- Describe Roof Type
- 1. Flat Roof
- North Tower – Evidence of Ponding continued...

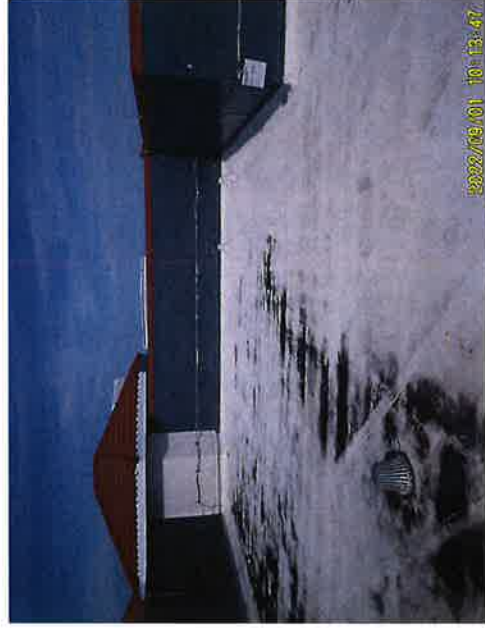
Photo 87

- Describe Roof Type
- 1. Flat Roof
- East Tower – Evidence of Ponding

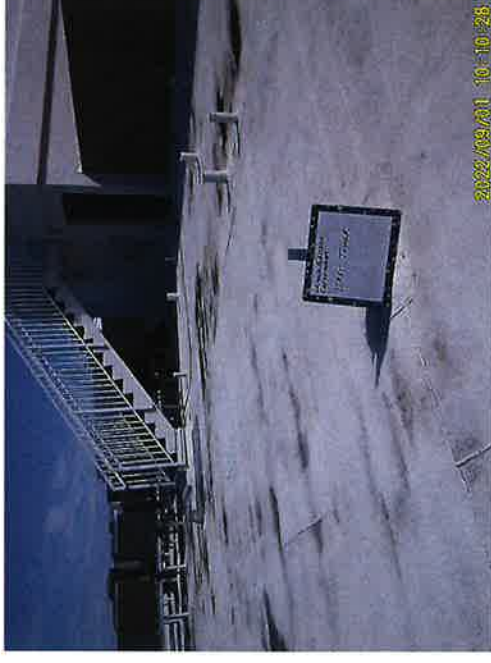
Photo 90

- Describe Roof Type
 1. Flat Roof
- East Tower – Evidence of Ponding continued...

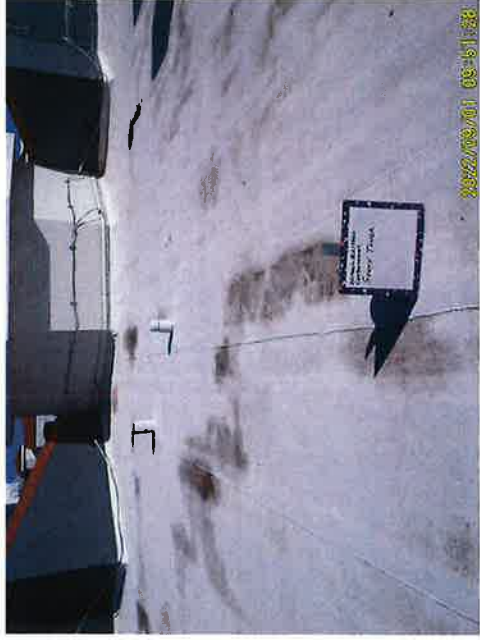
Photo 91

- Describe Roof Type
- 1. Flat Roof
- South Tower – Evidence of Ponding

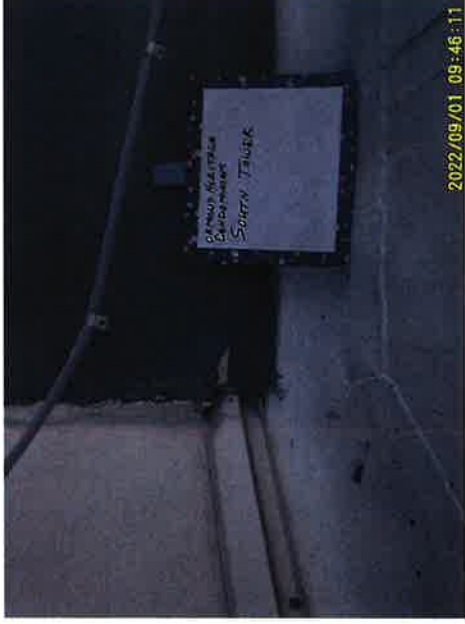
Photo 93

- Describe Roof Type
- 1. Flat Roof
- South Tower – Evidence of Ponding continued...

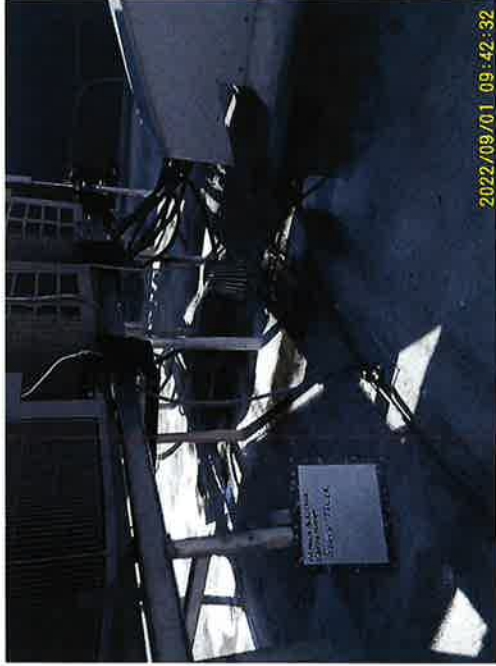
Photo 101

- Describe Roof Type
- 1. Flat Roof
- South Tower – Evidence of Ponding continued...

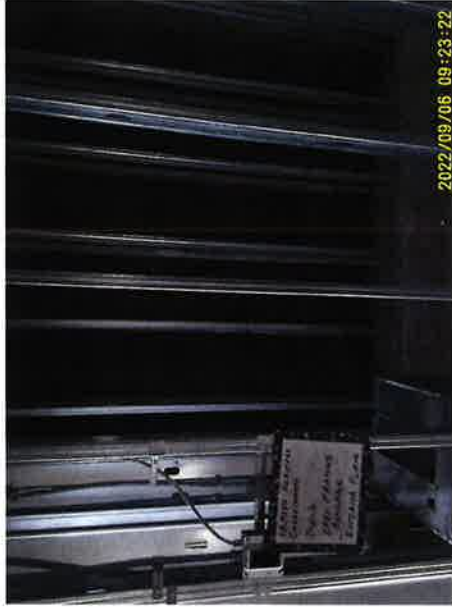
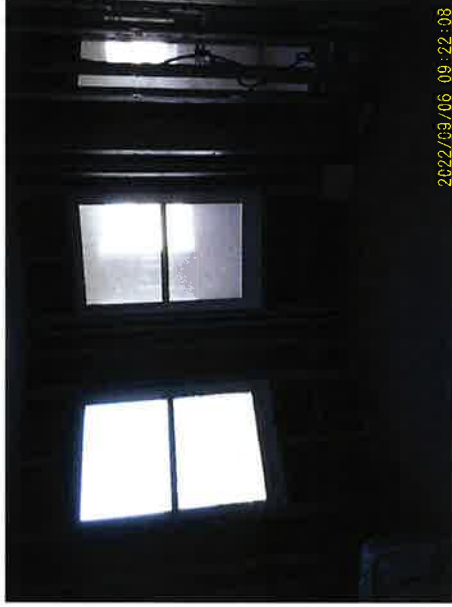
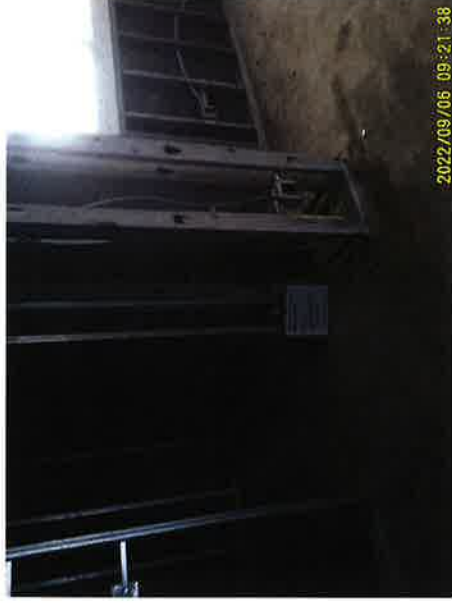
b. Floor system(s):	
1. Describe the floor system at each level, framing, material, typical spans and indicate condition:	PROVIDE PHOTO
Cast in place Reinforced concrete slabs - Good condition. Photo 7, 8 and 9

- Reinforced Concrete Slabs – Good
- Phase 2 – Open Framing, Ext. Plane

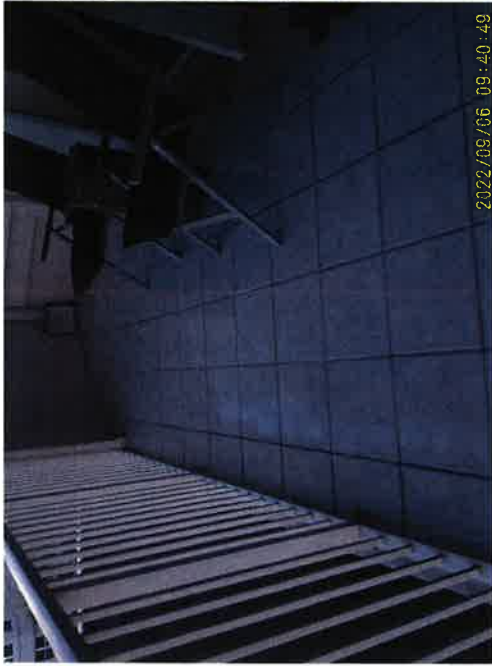
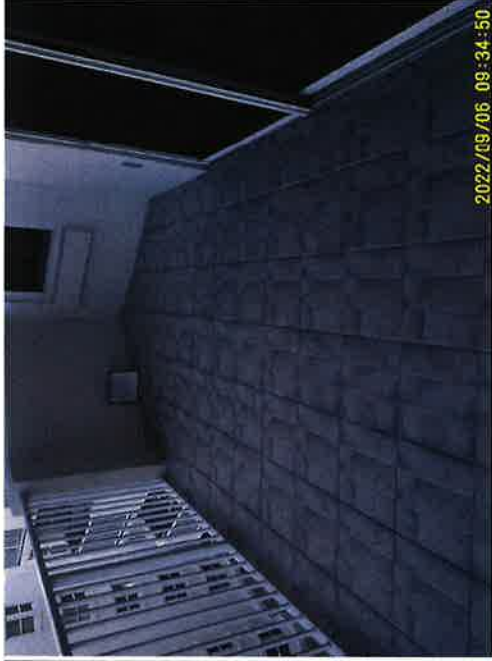
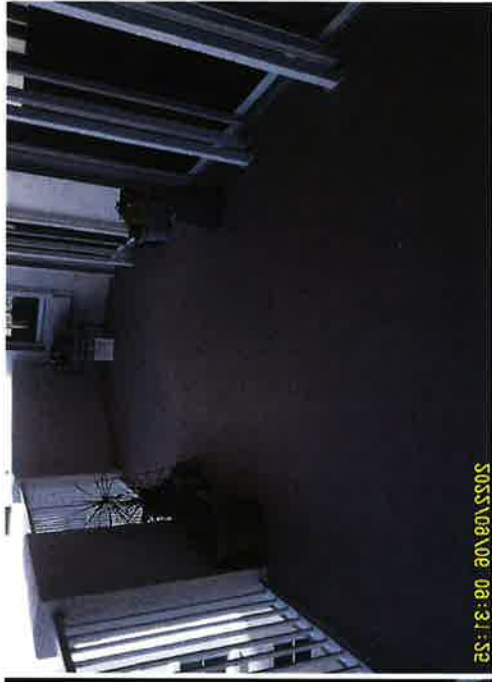
2. Balconies: Indicate location, framing system, material, and condition:	PROVIDE PHOTO
Exterior Reinforced Concrete balconies - Good	
Photo 1, 2, 3, 4, 5, 6, 10, 11, 40, 41, 42, 43, 44, 45, 46, 47, 48, 49, 50, 51, 52, 53, 54, 55, 56, 57, 58, 59, 60, 61, 62, 63, 95, 96, 97, 98, 99, and 100

- Reinforced Concrete Balconies – Good
- Balcony (Misc. Location)

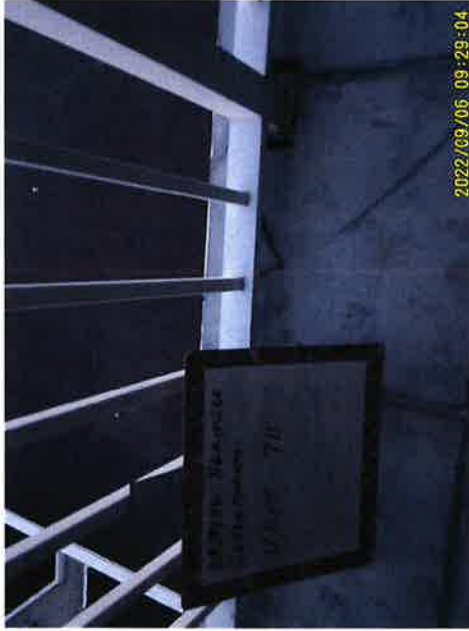
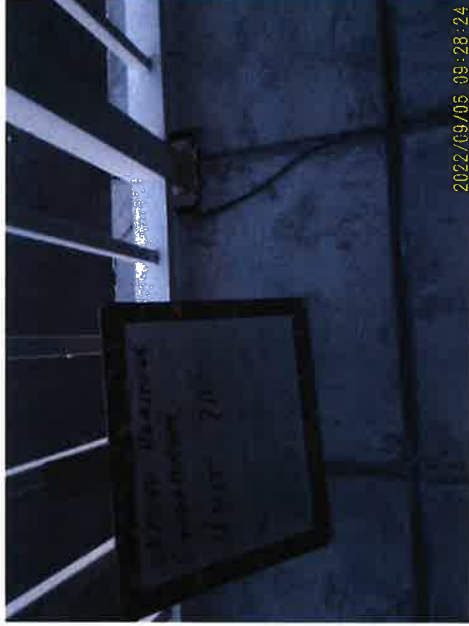
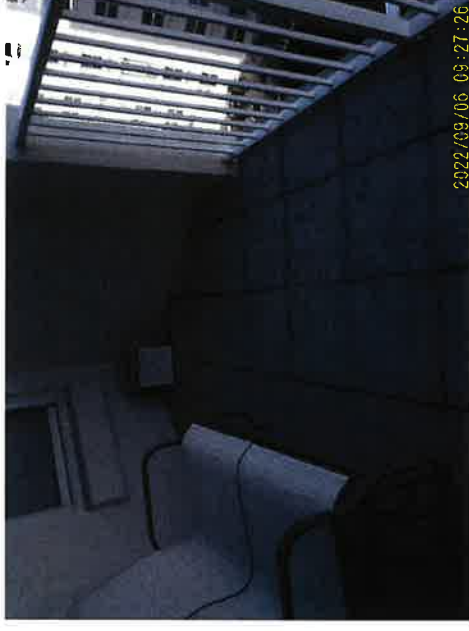
- Reinforced Concrete Balconies – Good
- Balcony, Unit 711

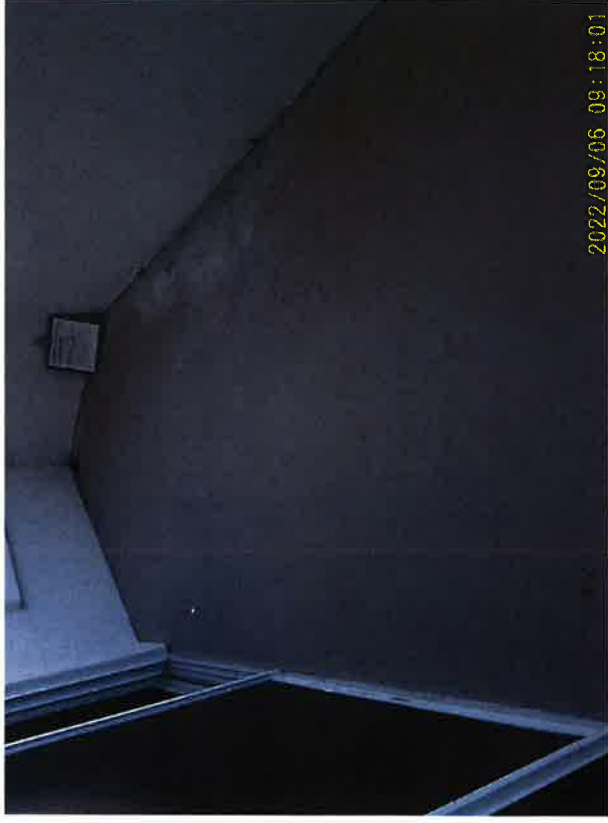
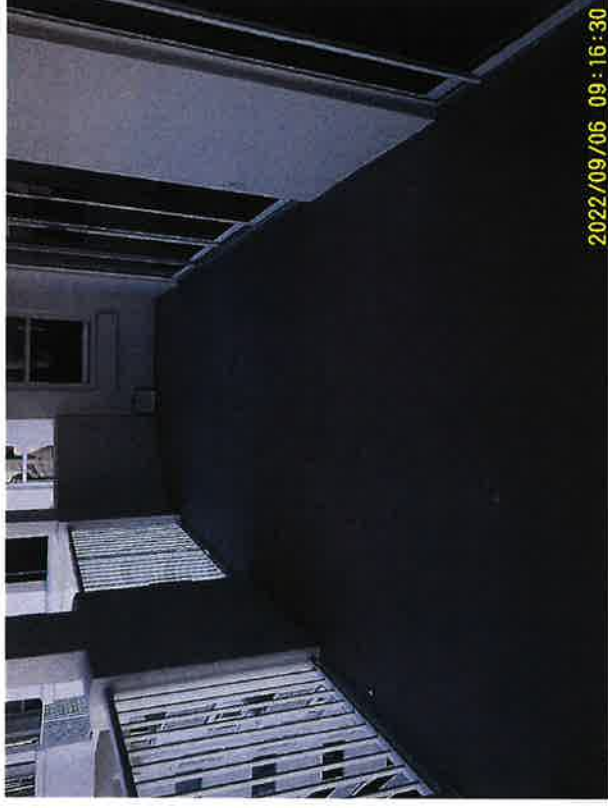
- Reinforced Concrete Balconies – Good
- Balcony (Misc. Location)

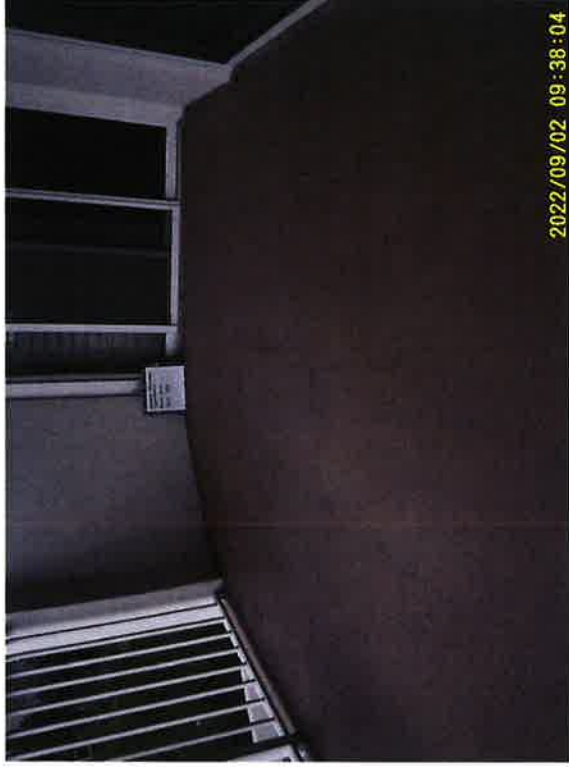
- Reinforced Concrete Balconies – Good
- Balcony (Misc. Location)

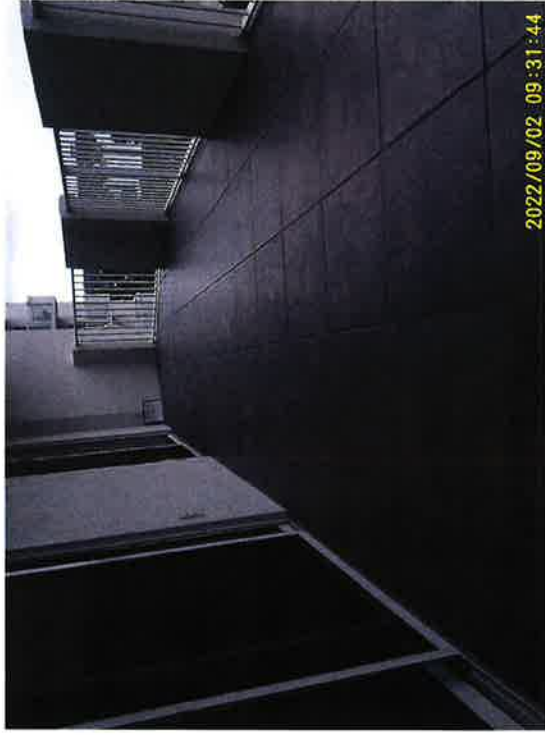
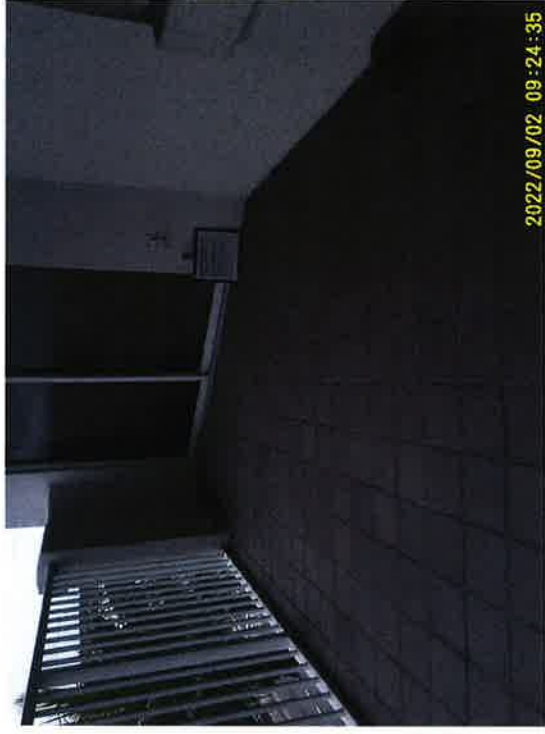
- Reinforced Concrete Balconies – Good
- Balcony, South Tower – Unit 601/2

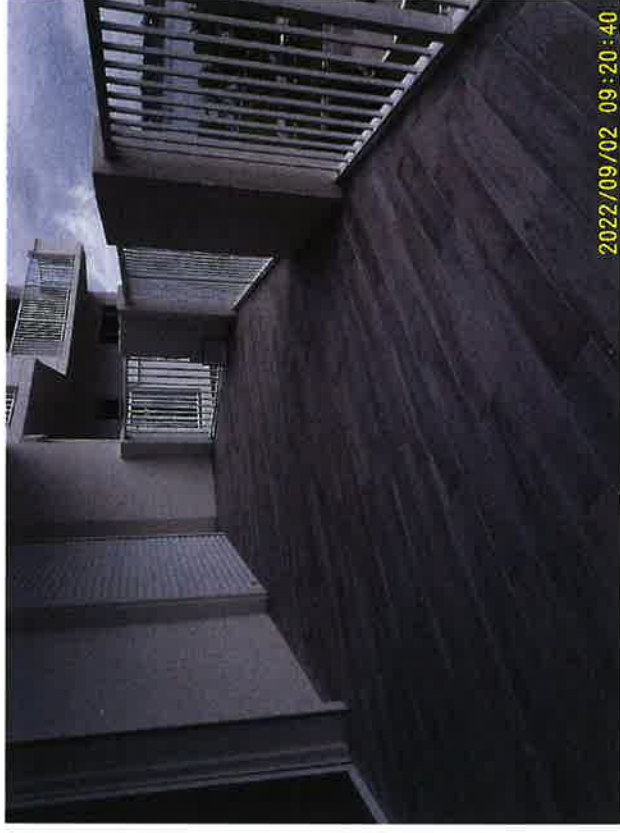
Photo 45

- Reinforced Concrete Balconies – Good
- Balcony (Misc. Location)

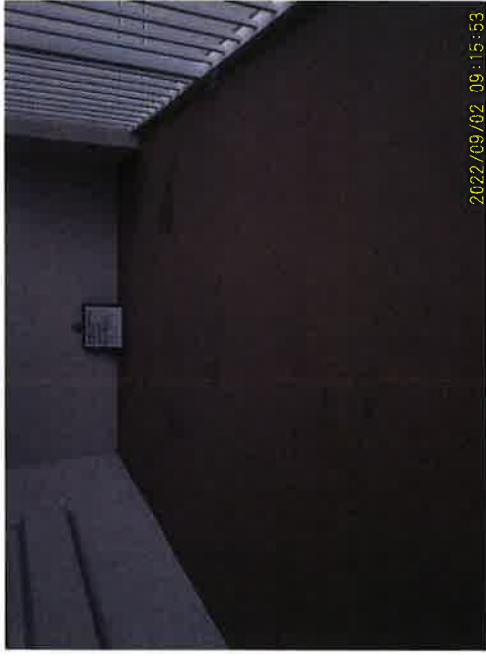
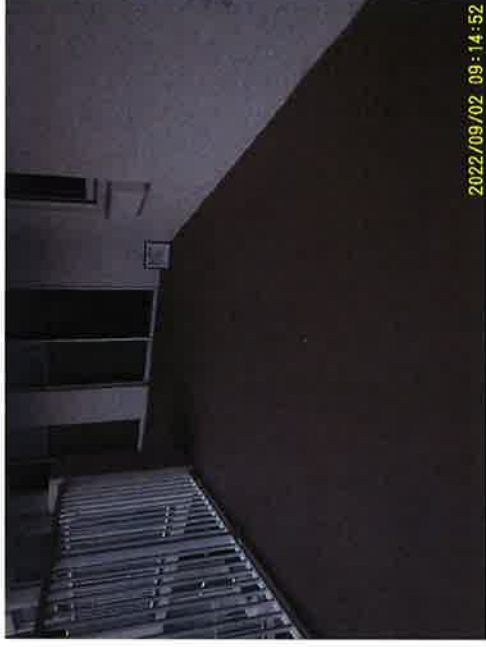
- Reinforced Concrete Balconies – Good
- Balcony, South Tower – Unit 704/2

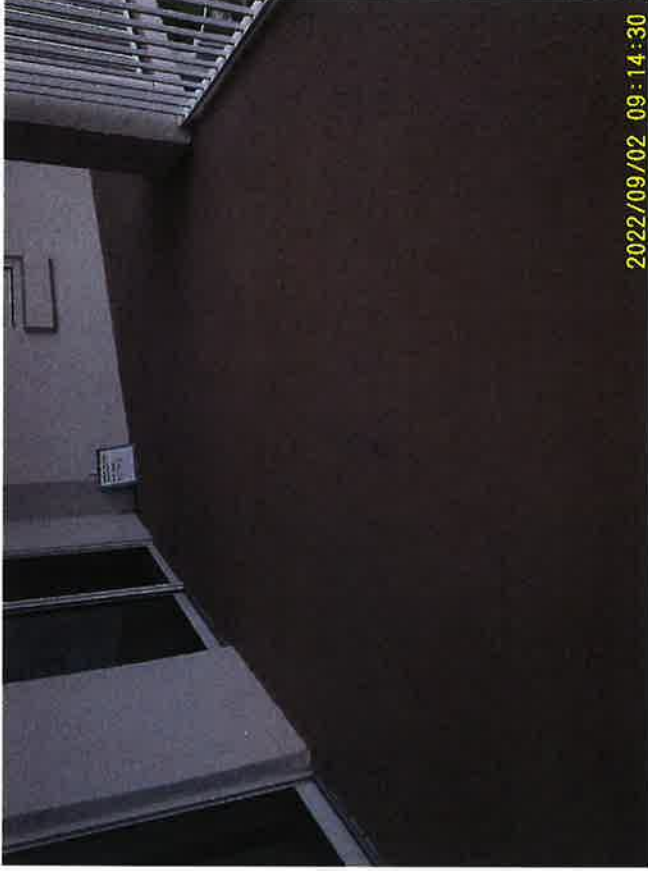
Photo 48

- Reinforced Concrete Balconies – Good
- Balcony (Misc. Location)

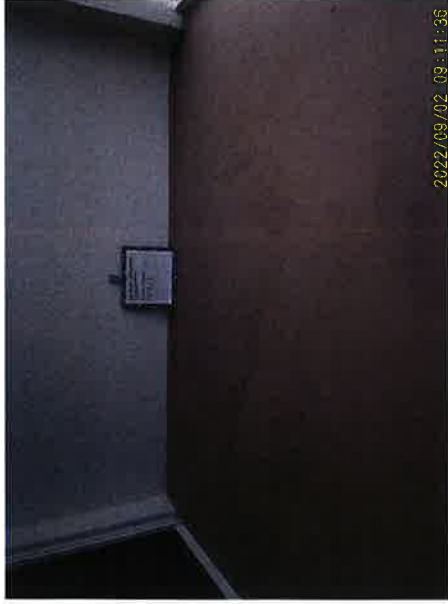
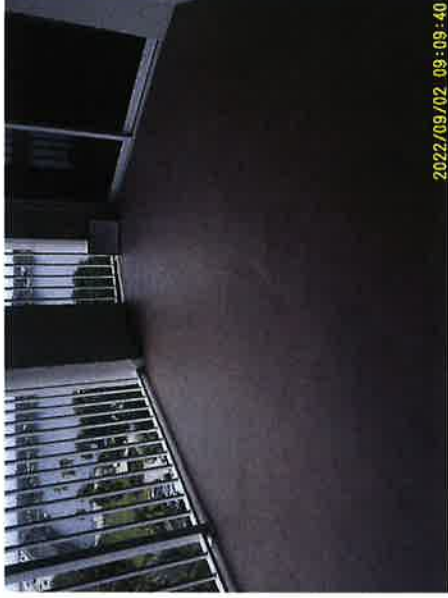
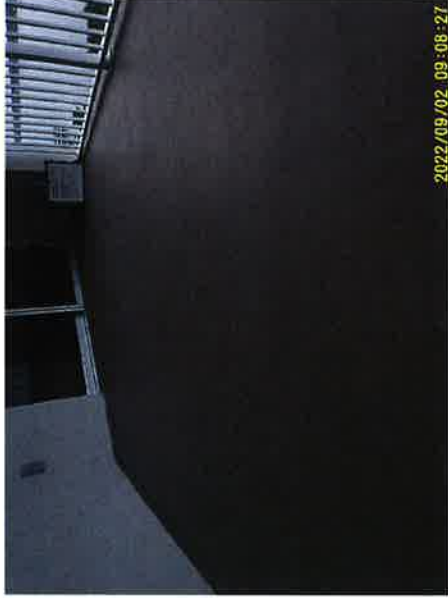
- Reinforced Concrete Balconies – Good
- Balcony, South Tower – Phase 4/1, 4/2, and 4/3

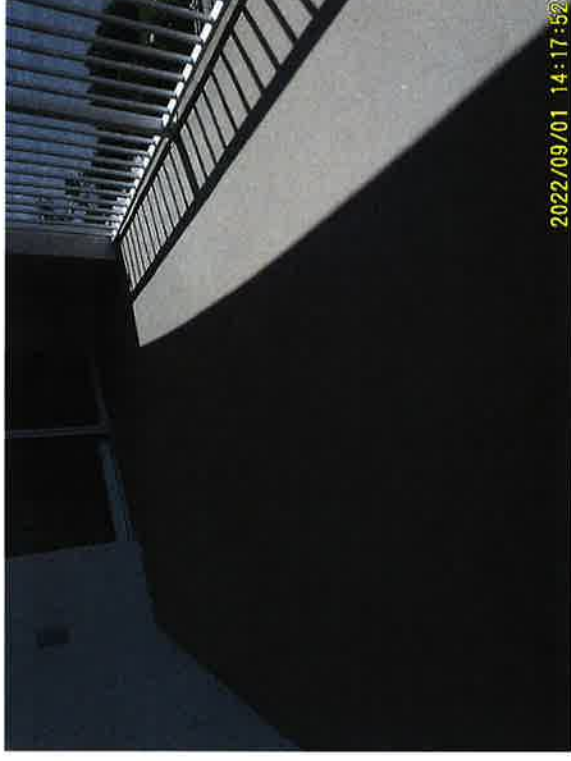
Photo 52

- Reinforced Concrete Balconies – Good
- Balcony (Misc. Location)

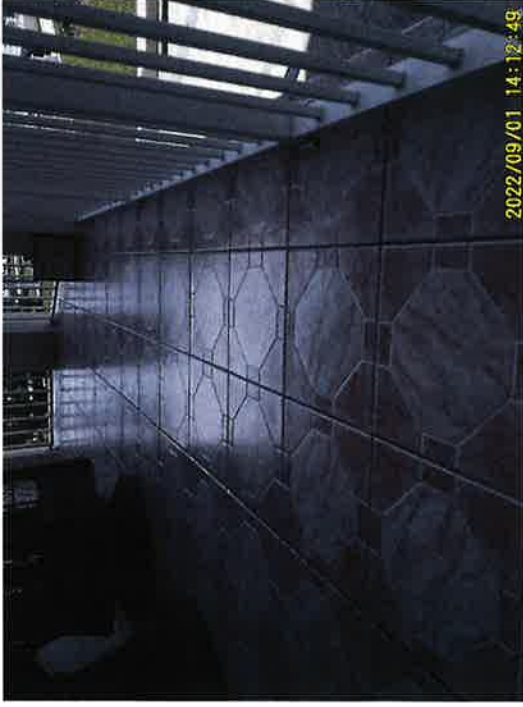
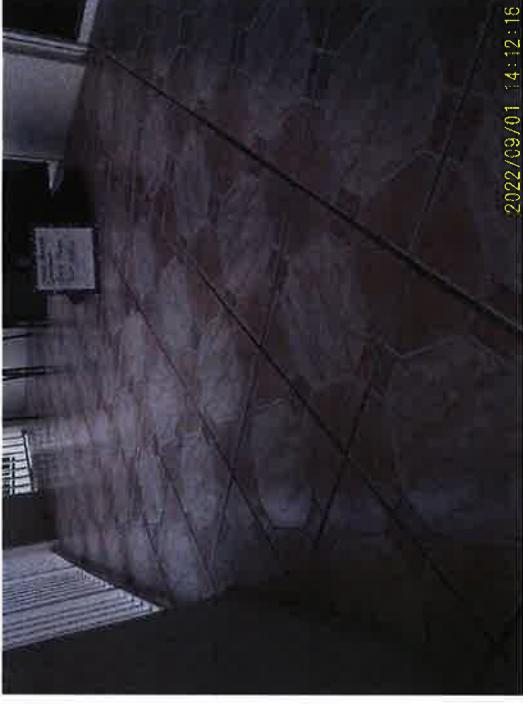
- Reinforced Concrete Balconies – Good
- Balcony, South Tower – Unit 204/2

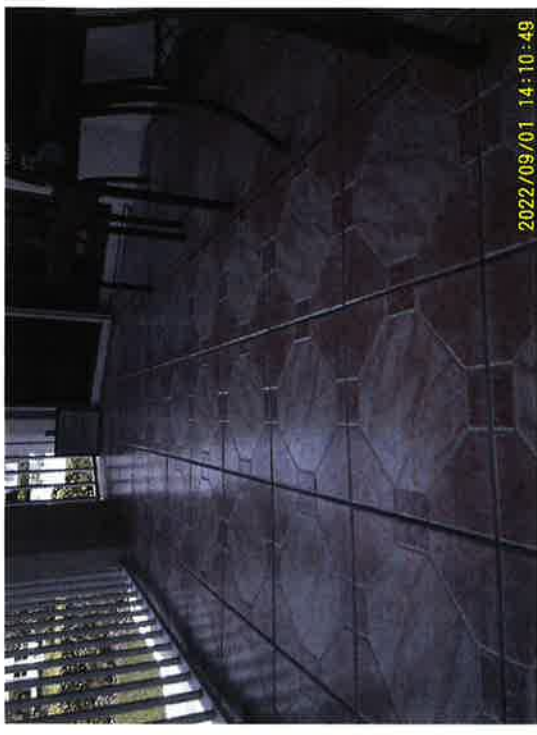
Photo 55

- Reinforced Concrete Balconies – Good
- Balcony, South Tower – Unit 204/2 continued...

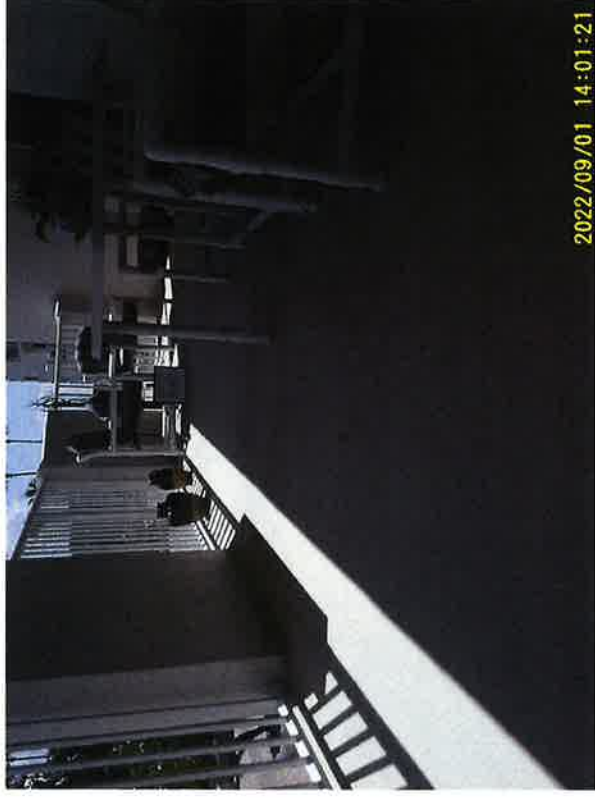
Photo 56

- Reinforced Concrete Balconies – Good
- Balcony (Misc. Location)

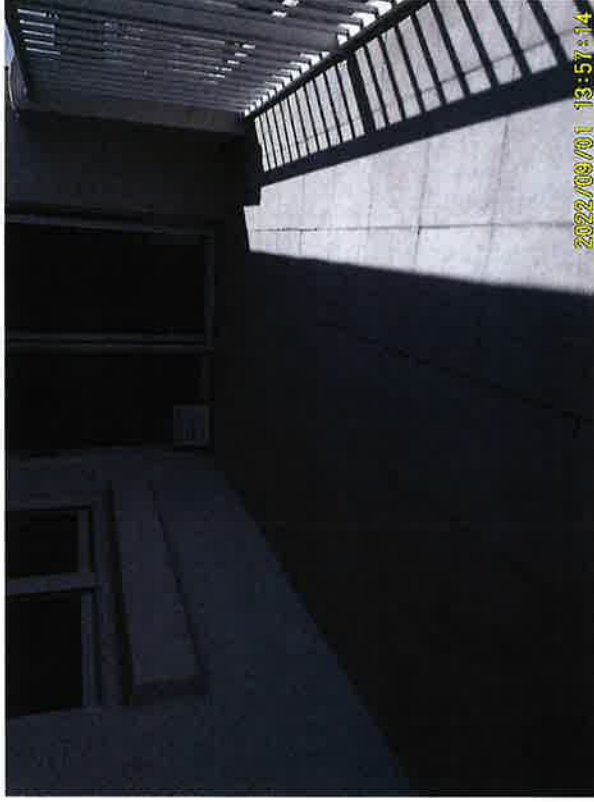
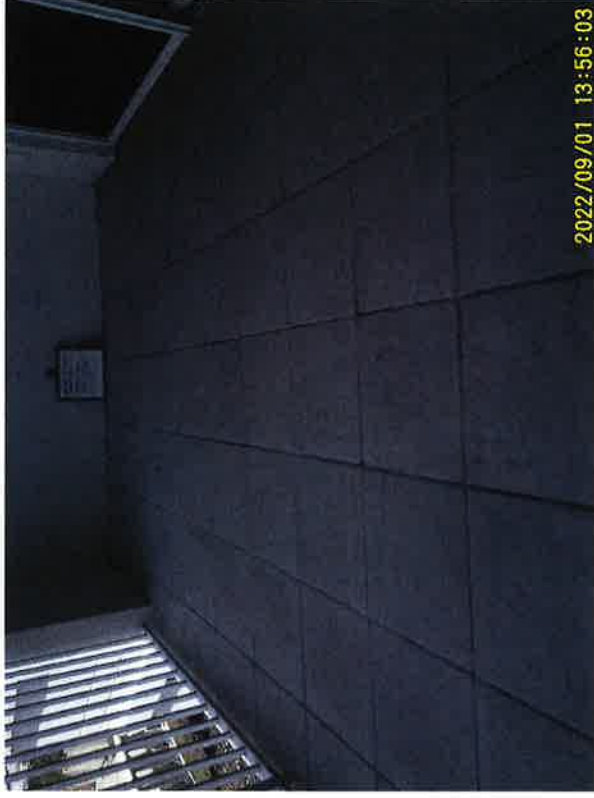
- Reinforced Concrete Balconies – Good
- Balcony (Misc. Location) continued....

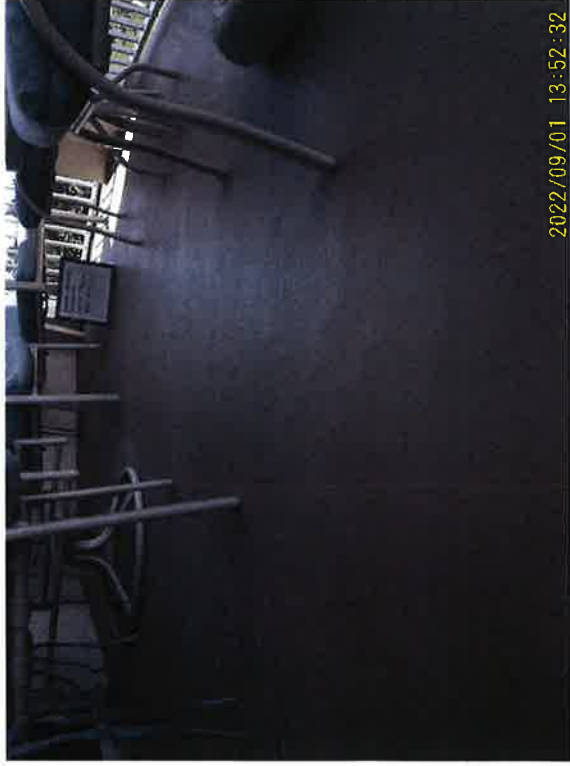
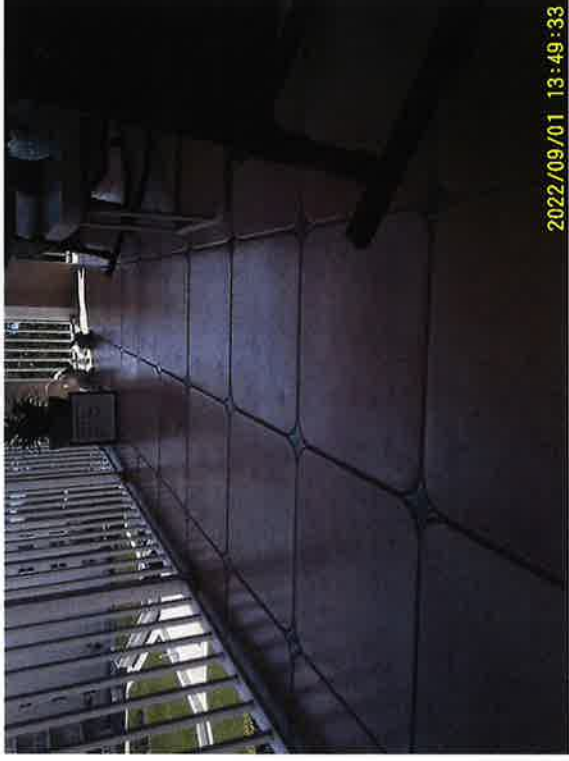
- Reinforced Concrete Balconies – Good
- Balcony (Misc. Location) continued....

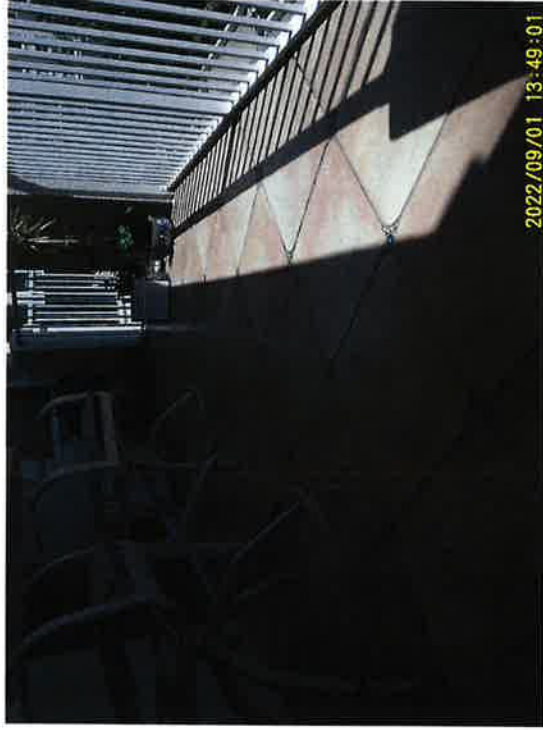
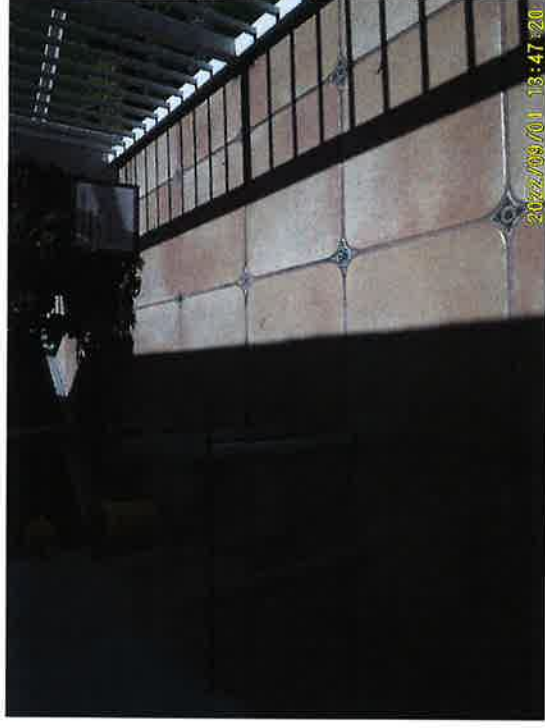
- Reinforced Concrete Balconies – Good
- Balcony (Misc. Location) continued....

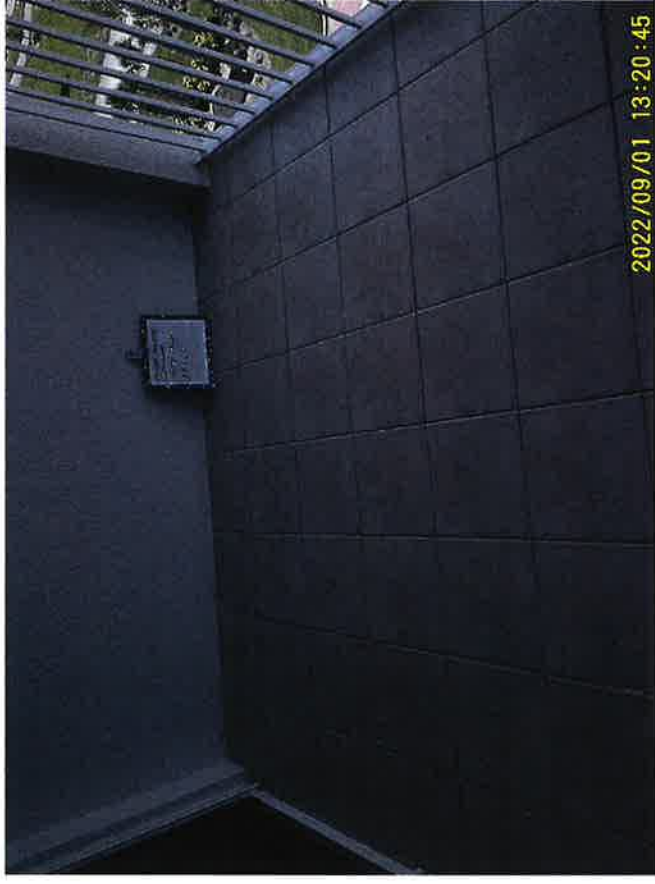
Photo 63

- Reinforced Concrete Balconies – Good
- Balcony, North Tower – Phase 6/1

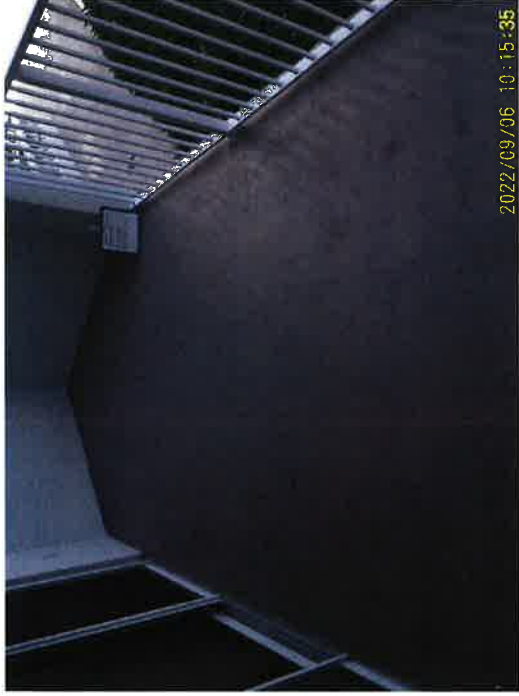
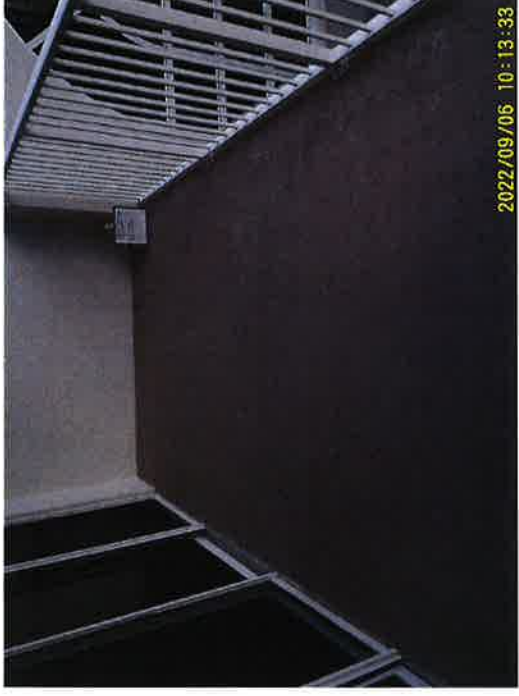
- Reinforced Concrete Balconies – Good
- Balcony (Misc. Location)

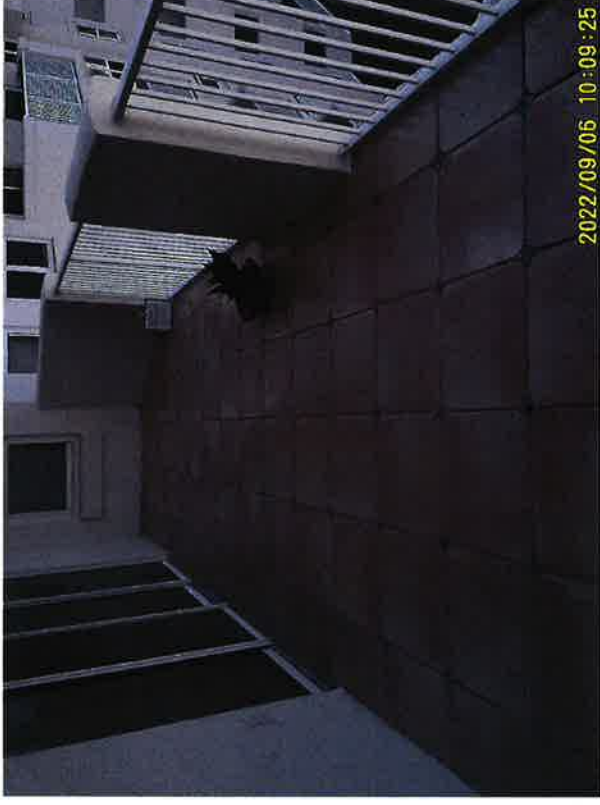
Photo 97

- Reinforced Concrete Balconies – Good
- Balcony (Misc. Location)

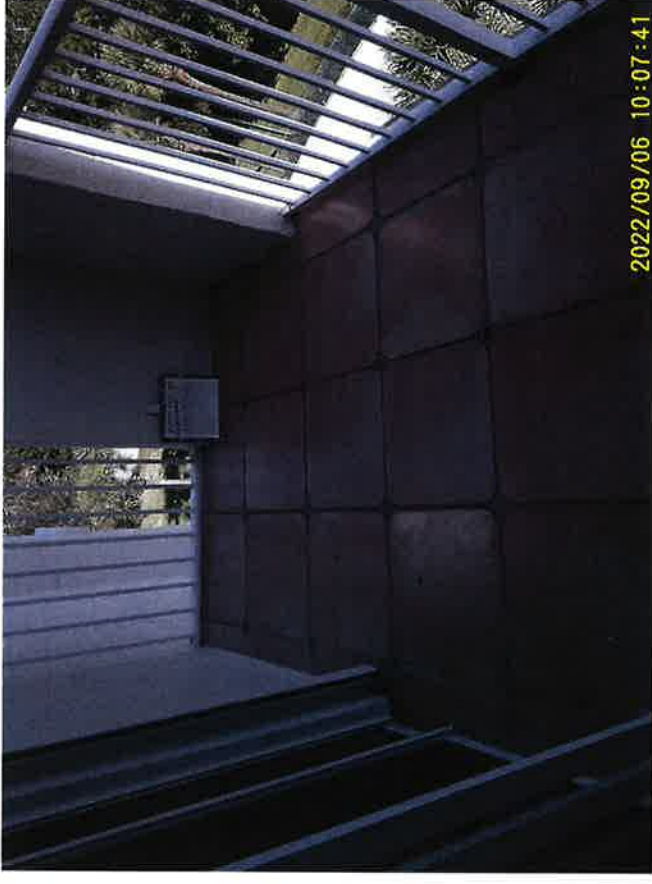
Photo 98

- Reinforced Concrete Balconies – Good
- Balcony, Unit 713/1

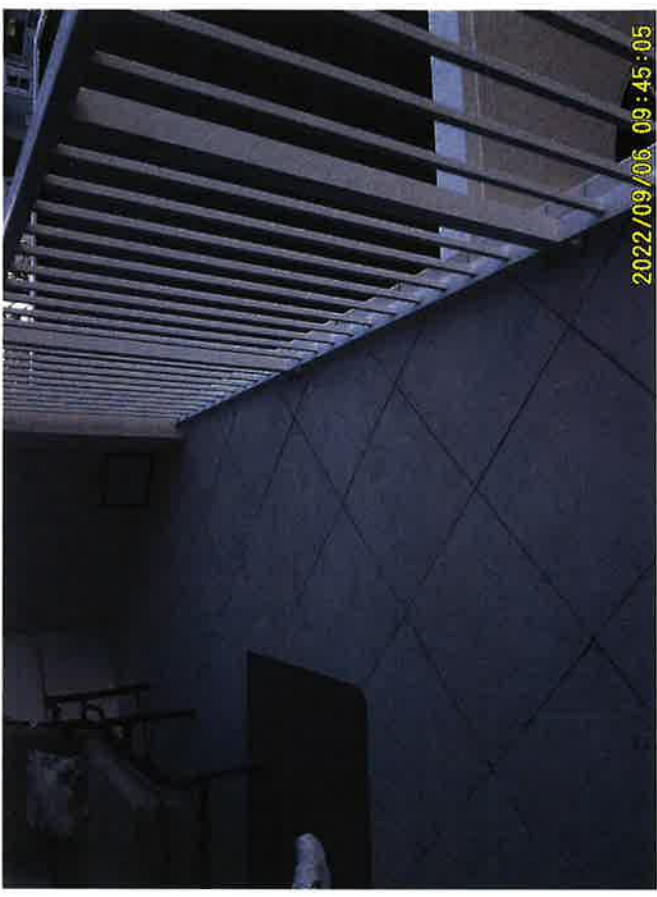
Photo 99

- Reinforced Concrete Balconies – Good
- Balcony (Misc. Location)

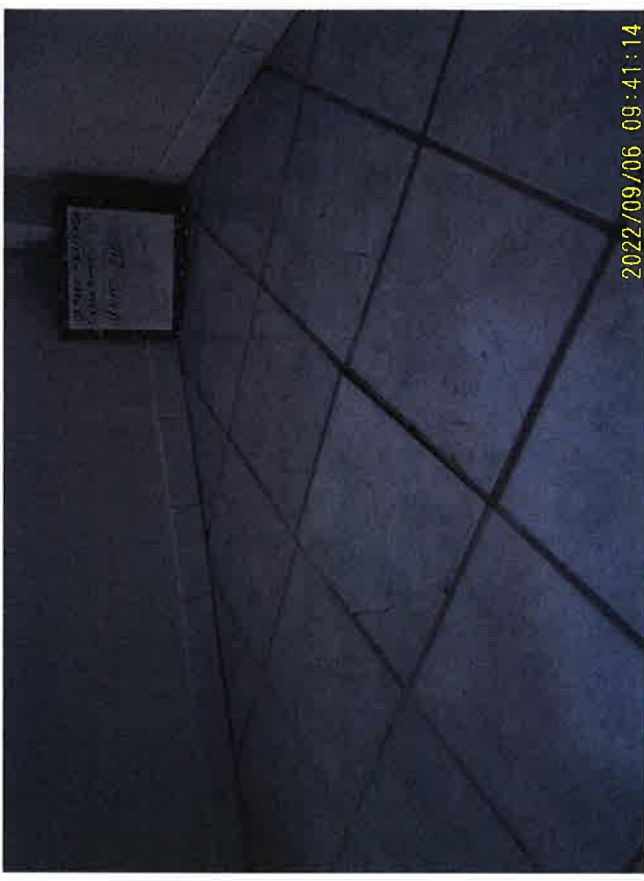
Photo 100

- Reinforced Concrete Balconies – Good
- Balcony, Unit 510

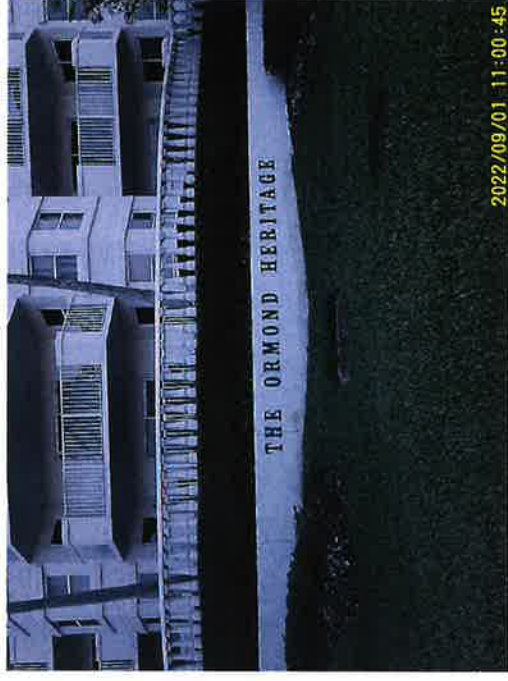
Photo 83

- Metal studs on center, masonry block, and synthetic stucco finish on ext. walls
- Center Wall

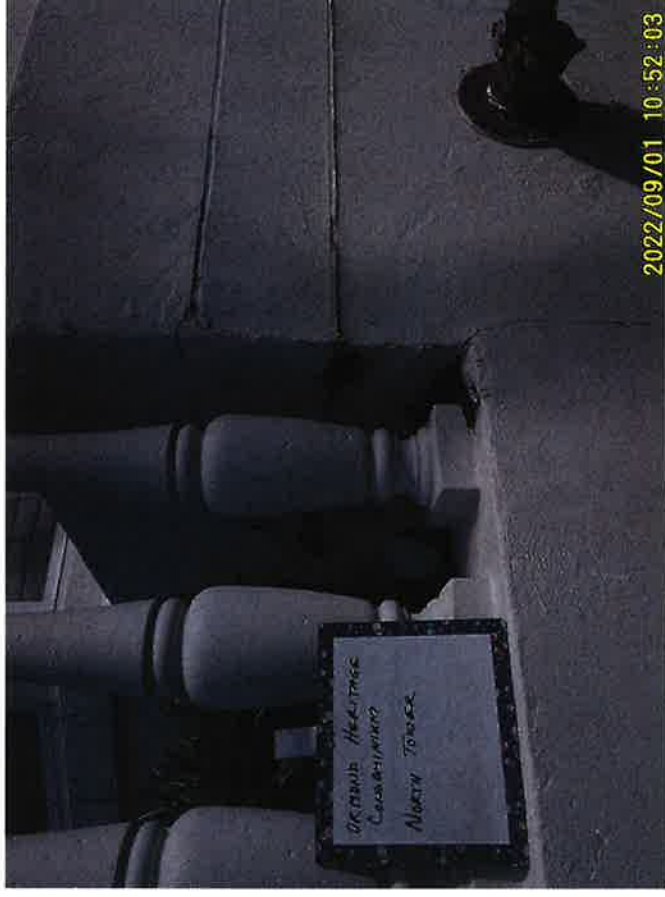
Photo 84

North Tower and South Tower retaining walls (Photos 84, 85, and 86)

- Metal studs on center, masonry block, and synthetic stucco finish on ext. walls continued..
- North Tower wall

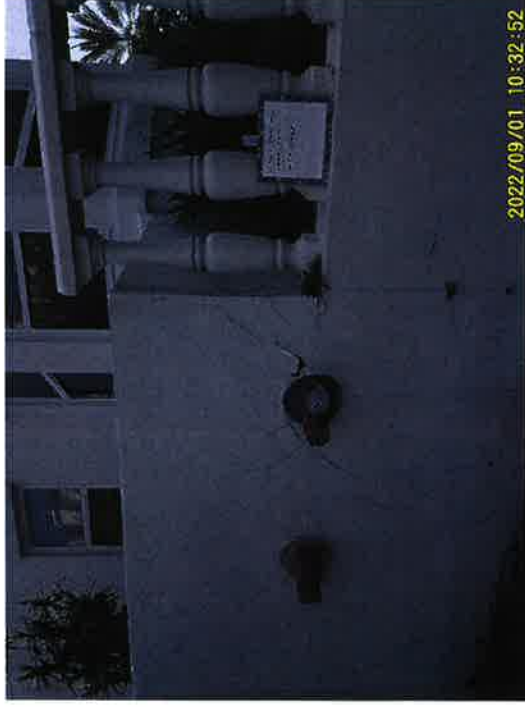
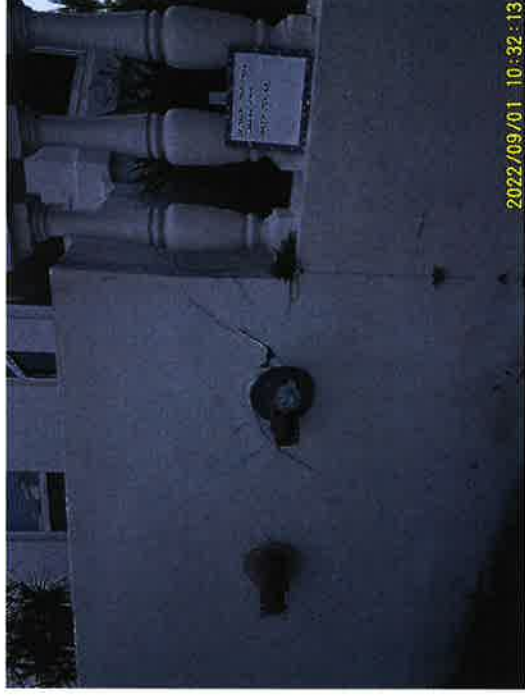
- Metal studs on center, masonry block, and synthetic stucco finish on ext. walls continued..
- South Tower wall
